EFFECTS OF REMEDIAL MEASURES AGAINST LIQUEFACTION  
AT 1993 KUSHIRO-OKI EARTHQUAKE

S. Iai<sup>1)</sup>, Y. Matsunaga<sup>1)</sup>, T. Morita<sup>1)</sup>, M. Miyata<sup>1)</sup>, H. Sakurai<sup>1)</sup>,  
H. Oishi<sup>2)</sup>, H. Ogura<sup>3)</sup>, Y. Ando<sup>4)</sup>, Y. Tanaka<sup>5)</sup> and M. Kato<sup>5)</sup>

1) Port and Harbour Research Institute, Yokosuka, Japan

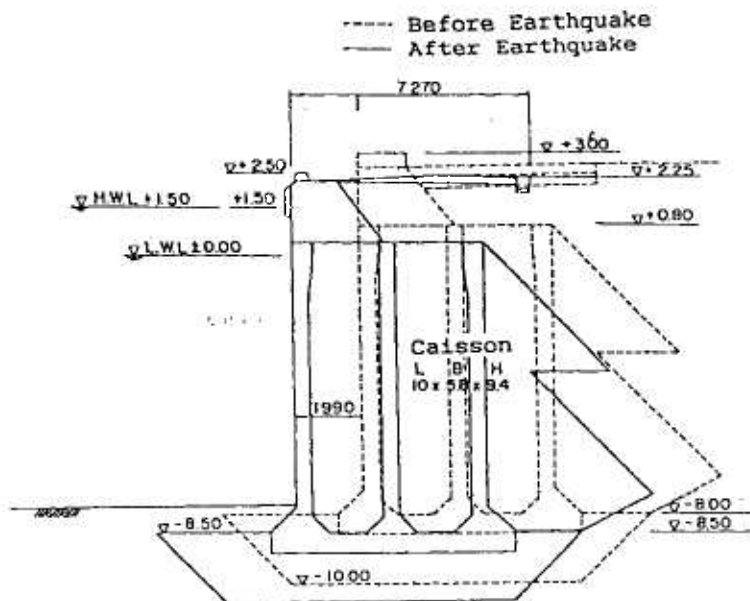
The most serious damage to the gravity quay walls in Kushiro Port was found at the North Pier in the East Port District. The location is designated in Fig. 2 as the site A. As shown in Fig. 6, displacement toward sea registered 2.0 meters at maximum, settlement 0.4 meters at maximum. The ground conditions shown in Fig. 7 indicates possibility of liquefaction down to an elevation of about -6.0 meters below the water level.

Fig.6 Damage to a quay wall at Site A

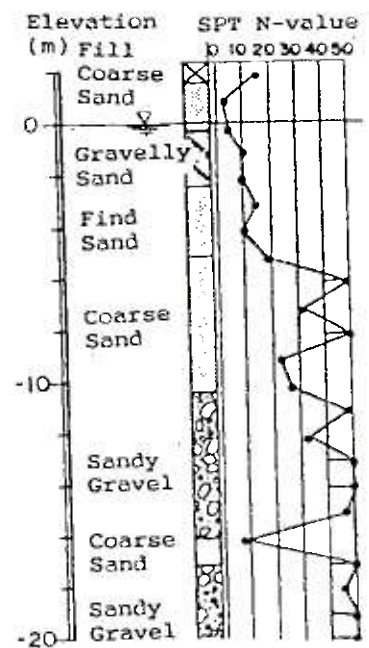
Fig.7 Ground Condition at Site A

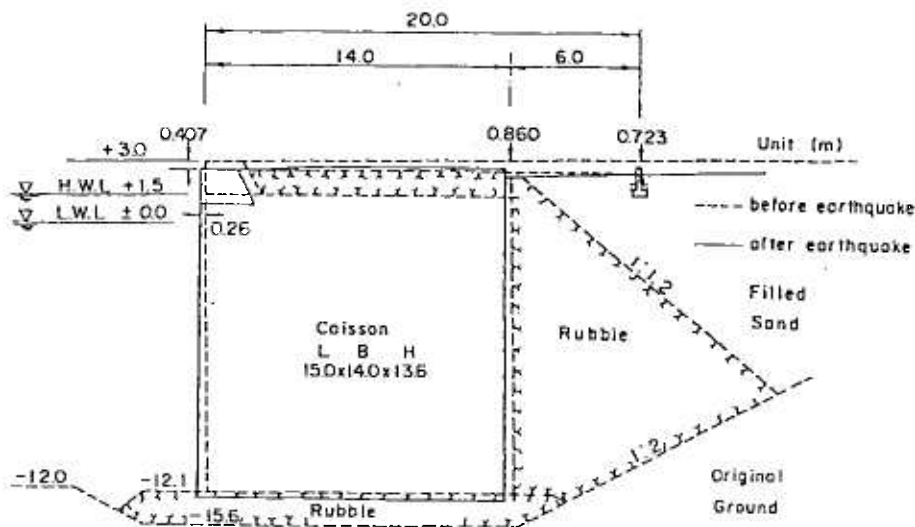
Among the gravity quay walls affected by liquefaction of backfill sand, quay walls designed with a seismic coefficient of 0.2 suffered relatively minor displacement. An example with a water depth of 12 meters is shown in Fig. 8. This quay wall is located at the south end of the Pier No.2 in the West Port District shown in Fig. 2 designated as the site B. As understood from the height to width ratio of the caisson being close to unity, the quay wall was designed to resist relatively strong earthquake motions.

earthquake hit the Kushiro area before the work was actually done. The backfill sand liquefied due to the earthquake. The caisson suffered deformation as shown in Fig. 8 but the displacement toward sea was only about 0.3 meters.

Fig. 8 Damage to a quay wall at Site B

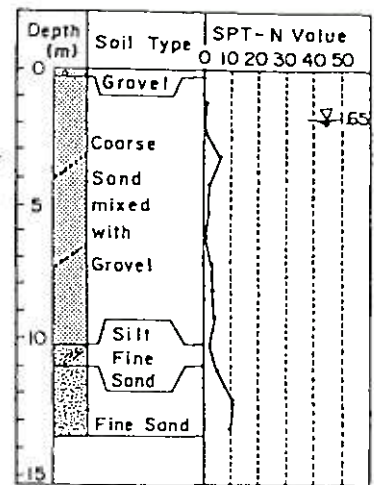
The backfill sand at this pier was loosely deposited and was of a coarse sand as shown in Fig. 9. It was planned to be compacted as remedial measures against liquefaction; unfortunately the

Fig. 9 Ground Condition at Site B

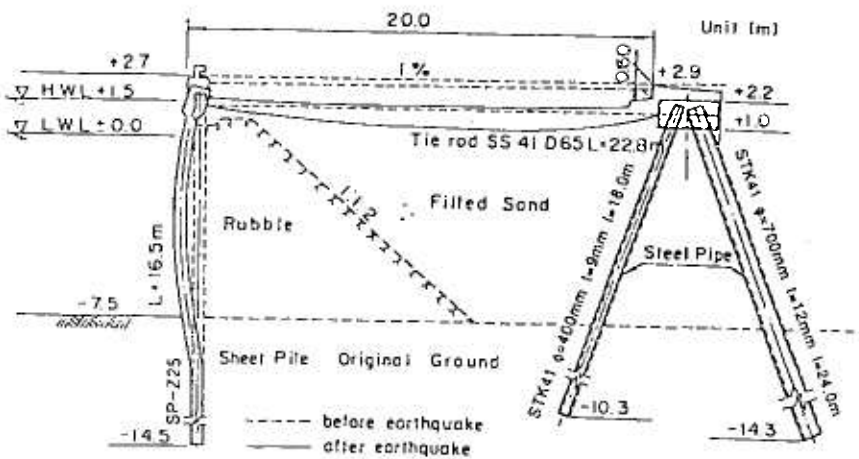
The most serious damage to the sheet pile quay walls in Kushiro Port was found at the Fishery Pier in the East Port District. The location is designated in Fig. 2 as the site C. The structure of this quay wall is of a steel sheet pile type anchored by battered steel piles. The cross section is shown in Fig. 10. As shown in Fig. 11, the ground at this pier consists of a loosely deposited backfill sand with a thickness of about ten meters, underlain by medium to dense sand deposit which forms the original ground.

The earthquake caused liquefaction in the backfill sand, resulting in the serious deformation of the sheet pile wall as shown by the solid line in Fig. 10. In accordance with the deformation of the sheet pile wall, the apron exhibited serious settlement between the sheet pile wall and the anchor piles. Detailed investigation of the sheet pile wall by diving in the sea revealed that cracks opened in the steel sheet pile wall at an elevation of four meters below the water level.

Fig. 10 Damage to a quay wall at Site C

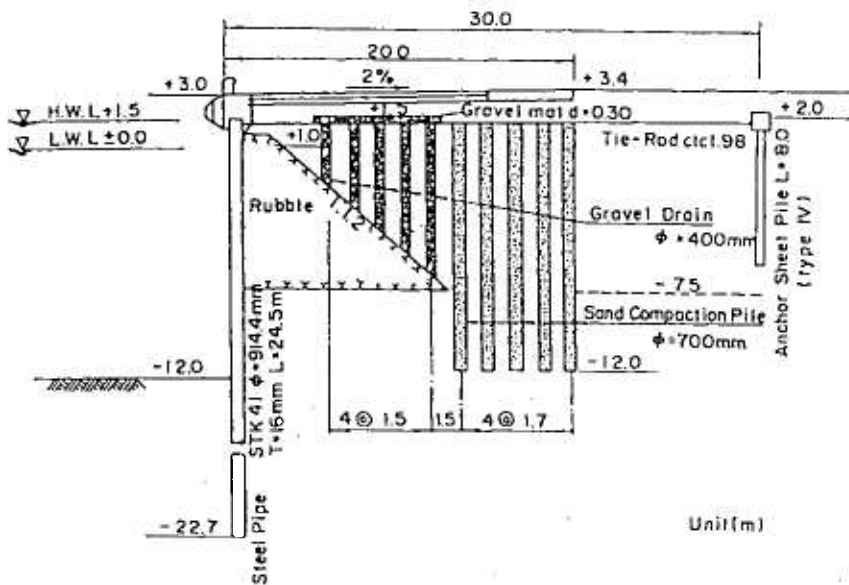
The structure of this quay wall is of a steel pipe pile wall anchored by a steel sheet pile wall with a water depth of 12 meters. The ground at this wall had originally consisted of fill sand with a thickness of about ten meters, underlain by the original ground of medium to dense sand. The backfill sand was later treated by a sand compaction pile method as shown in Fig. 12. The SPT N-values of the ground before and after the compaction are shown in Fig. 13. In order to avoid the adverse effect upon the existing steel pipe pile wall during the ground compaction work, gravel drains were installed near the wall as shown in Fig. 12.

Despite the strong shaking of the earthquake, the earthquake caused no effect on this quay wall. The measures against liquefaction as well as the overall design of the quay wall according to the current design practice (Ports and Harbours Bureau, 1991) was proven to be good enough to provide resistance the strong earthquake shaking.

Fig.12 Cross section of a quay wall at Site D

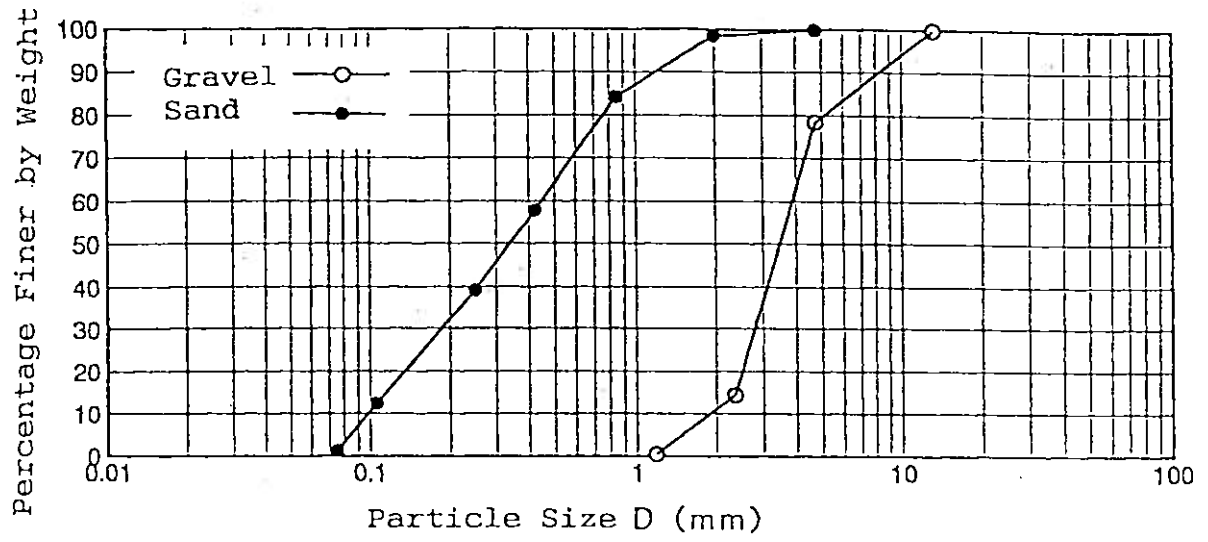
The gravel drain piles are 40 cm in diameter, installed at a space of 5.0 meters. The sand consisting of the ground and the gravels used for the drain have those gradations shown in Fig. 15. The 15% diameter of the filtering material (i.e. the gravel)  $d_{F15}$  and the 85% diameter of the sand  $D_{S85}$  read off from this figure are

$$d_{F15}/D_{S85} = 2.8 \quad (3)$$

This ratio should be more than adequate for passing such a filtering criterion as

Fig.15 Gradation of sand and gravel

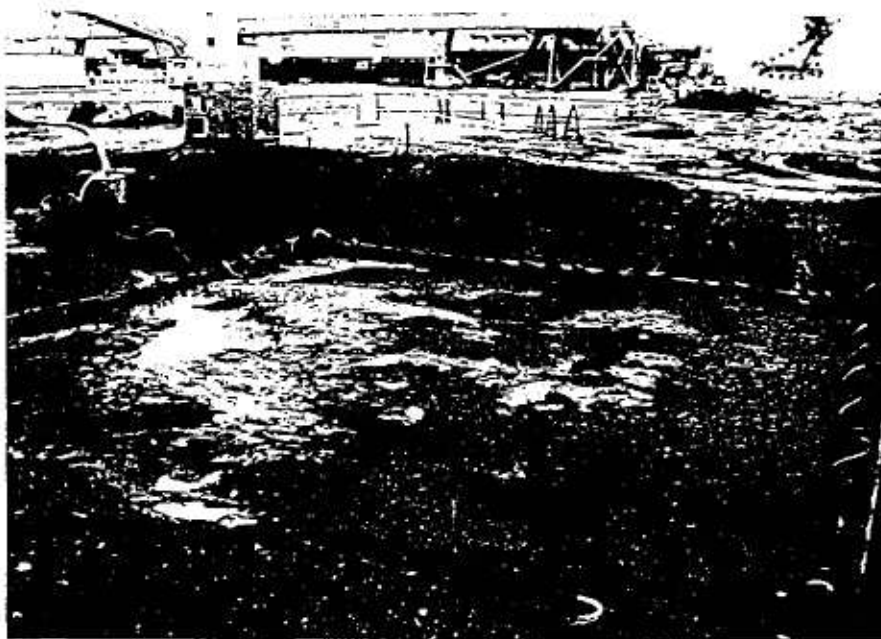
Excavation was done by at first lowering the existing water level at +1.20m to a level of +0.00 m, then by digging out to a level of +0.00 as shown in Figs. 16 and 17. Close eye inspection of a gravel drain, shown in Fig. 18, found no migration of sand.

Fig.16 General view of excavation of gravel drain site

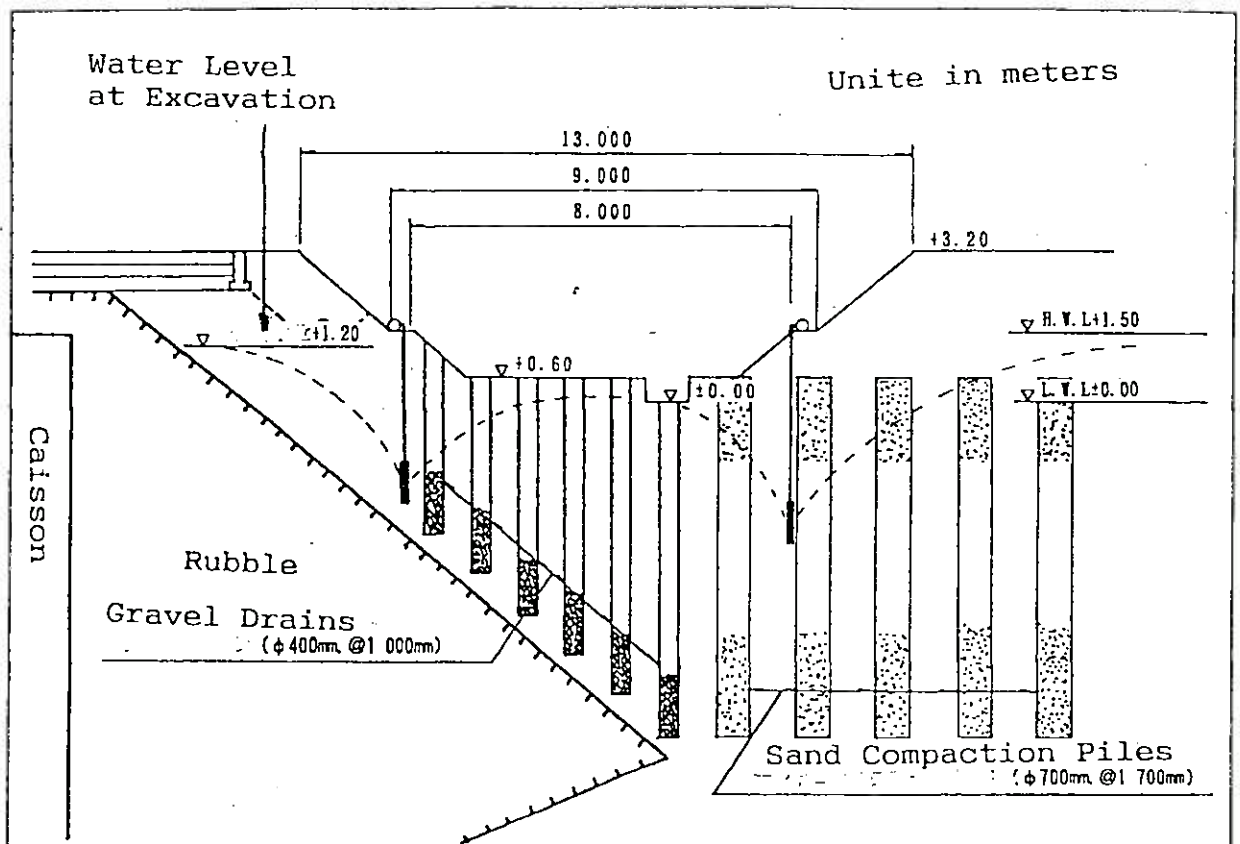
Fig.17 Cross section of excavation details

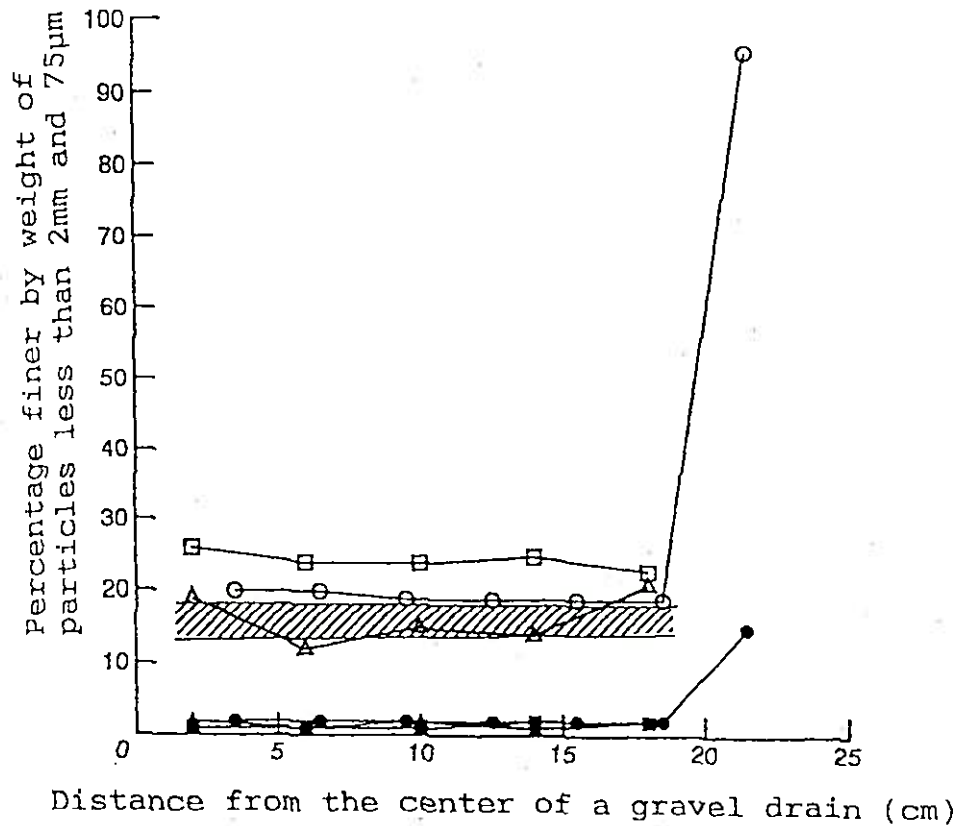
Sieving of the gravels sampled from the gravel drain resulted in Fig. 19, suggesting that there is not variation in the percentage of sandy materials (i.e. those with a particle size less than 2.0 mm) within the cross section of the gravel drain. However, there were about 20 percent of the sandy materials contained in the gravels as shown in the same figure. In order to examine the origin of those sandy materials, mineral analysis using X-ray

diffraction method was conducted on the sandy materials in the gravels, to be compared with those results on the sand consisting of the ground and the gravel. The mineral analysis resulted in that tridymite  $S_1O_2$  is commonly found in the sandy materials in the gravel drain and the gravel but not in the sand consisting of the ground. This result also confirmed the fact that no migration of sand into the gravel drain occurred during the earthquake.

Fig.19 Fine grained materials and sand contained in the gravels
