LIQUEFACTION-INDUCED DAMAGE TO BUILDINGS IN 1990 LUZON EARTHQUAKE

By Kohji Tokimatsu,¹ Associate Member, ASCE, Hisaya Kojima,²
Shinichi Kuwayama,³ Akio Abe,⁴ and Saburoh Midorikawa⁵

ABSTRACT: The Luzon Earthquake of 1990 ($M_s = 7.8$) caused soil liquefaction in a widespread area that in turn caused crucial damage to various structures. After presenting an overview of the geotechnical aspects of the earthquake, this paper describes damage patterns of buildings in Dagupan City where fine to silty sands liquefied extensively. Also presented are geomorphological conditions, Standard Penetration Test (SPT) results, and shear wave velocity (V_s) profiles determined by a Rayleigh wave method; and their relations to the building damage of the city. The buildings that suffered large settlement and tilting are found to be concentrated in the banks of active rivers and in the fills built on recently abandoned river channels. It is found that the currently available empirical correlations using SPT N -value can well estimate the extent of liquefaction-induced damage to buildings. The Rayleigh wave method used shows capability in determining cross sections of V_s structure in the near surfac

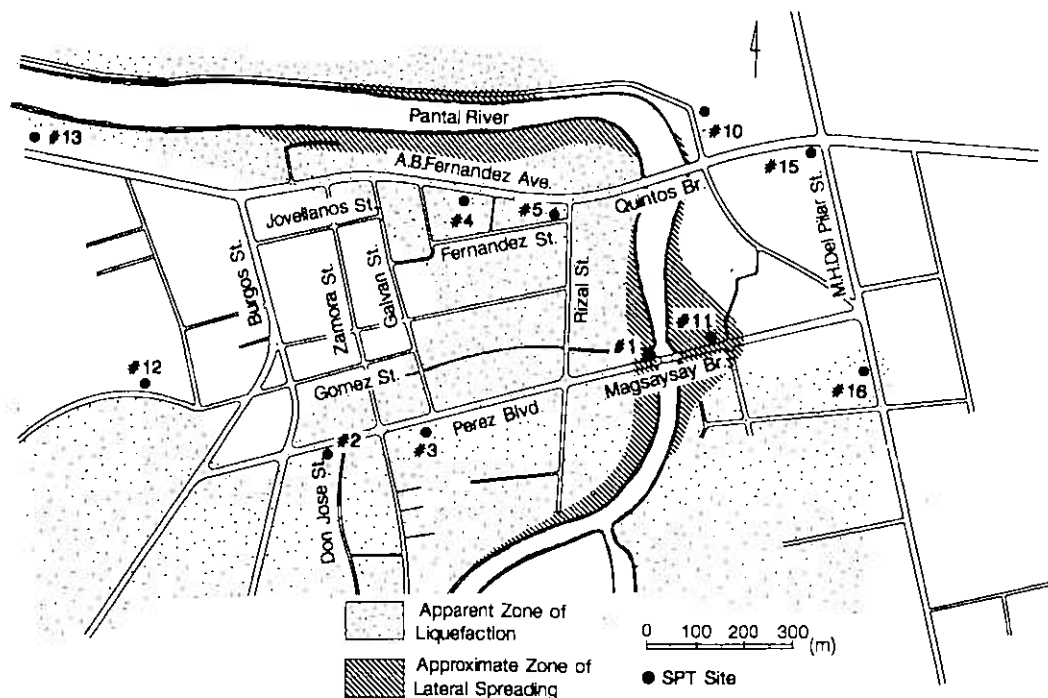
FIG. 2. Map of Dagupan Showing Zones of Liquefaction and Lateral Spreading and Locations of SPT Sites

Fig. 2 shows the approximate zone in which field manifestation of liquefaction such as a sand boil was evident after the 1990 earthquake. The zoning was made based on quick inspection during our site visit. Also shown in the figure is the area that is considered to have slid or spread, due to liquefaction of underlying soils. Many ground fissures that took place parallel to the course of the river in this area indicated that the ground has slid and expanded toward the river.

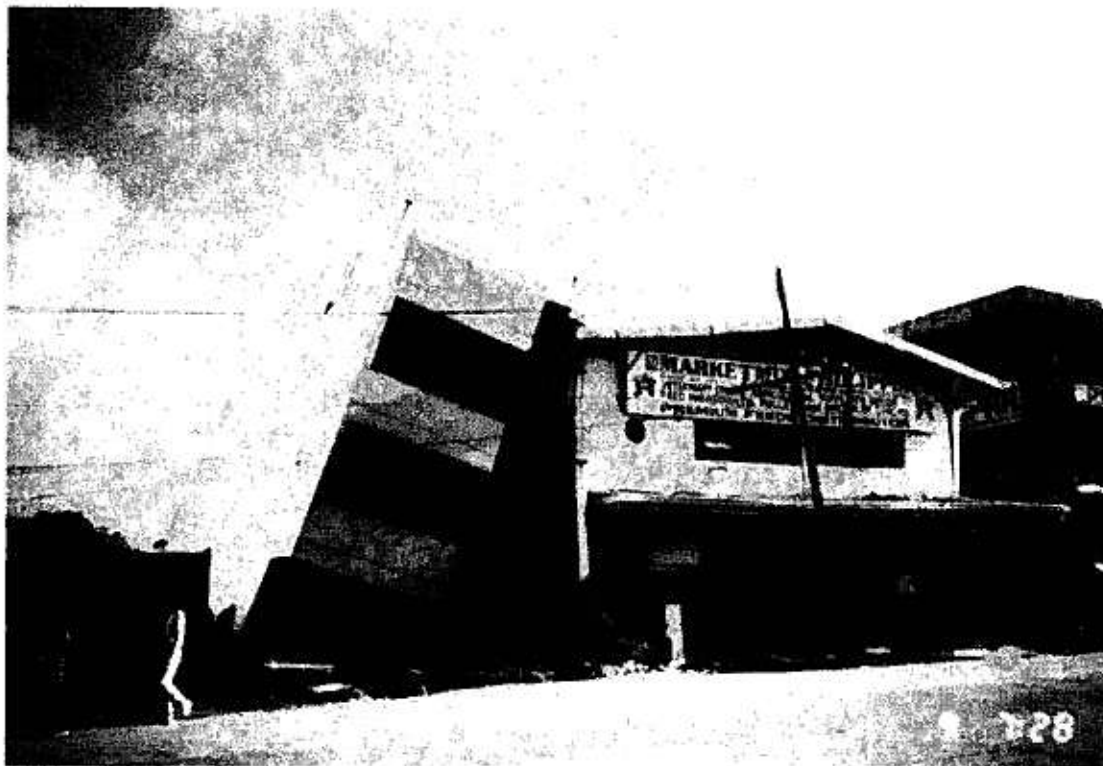
FIG. 3. Typical Bearing Failure of Building

Almost all damage to buildings is related to foundation bearing failure associated with soil liquefaction (Fig. 3). Damage due to strong ground shaking was rarely seen in the city. This includes the collapse of the upper portion of an unreinforced old church building on Zamora Street located outside the liquefied area. The peak ground acceleration in the nonliquefied region of the city during the July 16 event was estimated to be 1.8 m/s^2 (Midorikawa 1990).

Damage induced by structure-structure interaction was also observed in many places. Significant tilting of a massive building caused vital damage

to an adjacent building (Fig. 3), and large settlements of massive buildings resulted in differential settlement and associated failure of adjacent lighter buildings. Much of obvious damage to wooden houses was associated either with large settlement, differential settlement, or differential lateral movement of their foundations. The areas around many wooden houses in the extensively liquefied zone and in the lateral spreading zone were inundated due to ground subsidence. Many wooden houses in the lateral spreading zone were also destroyed due to differential lateral movement or differential settlement of their foundations.

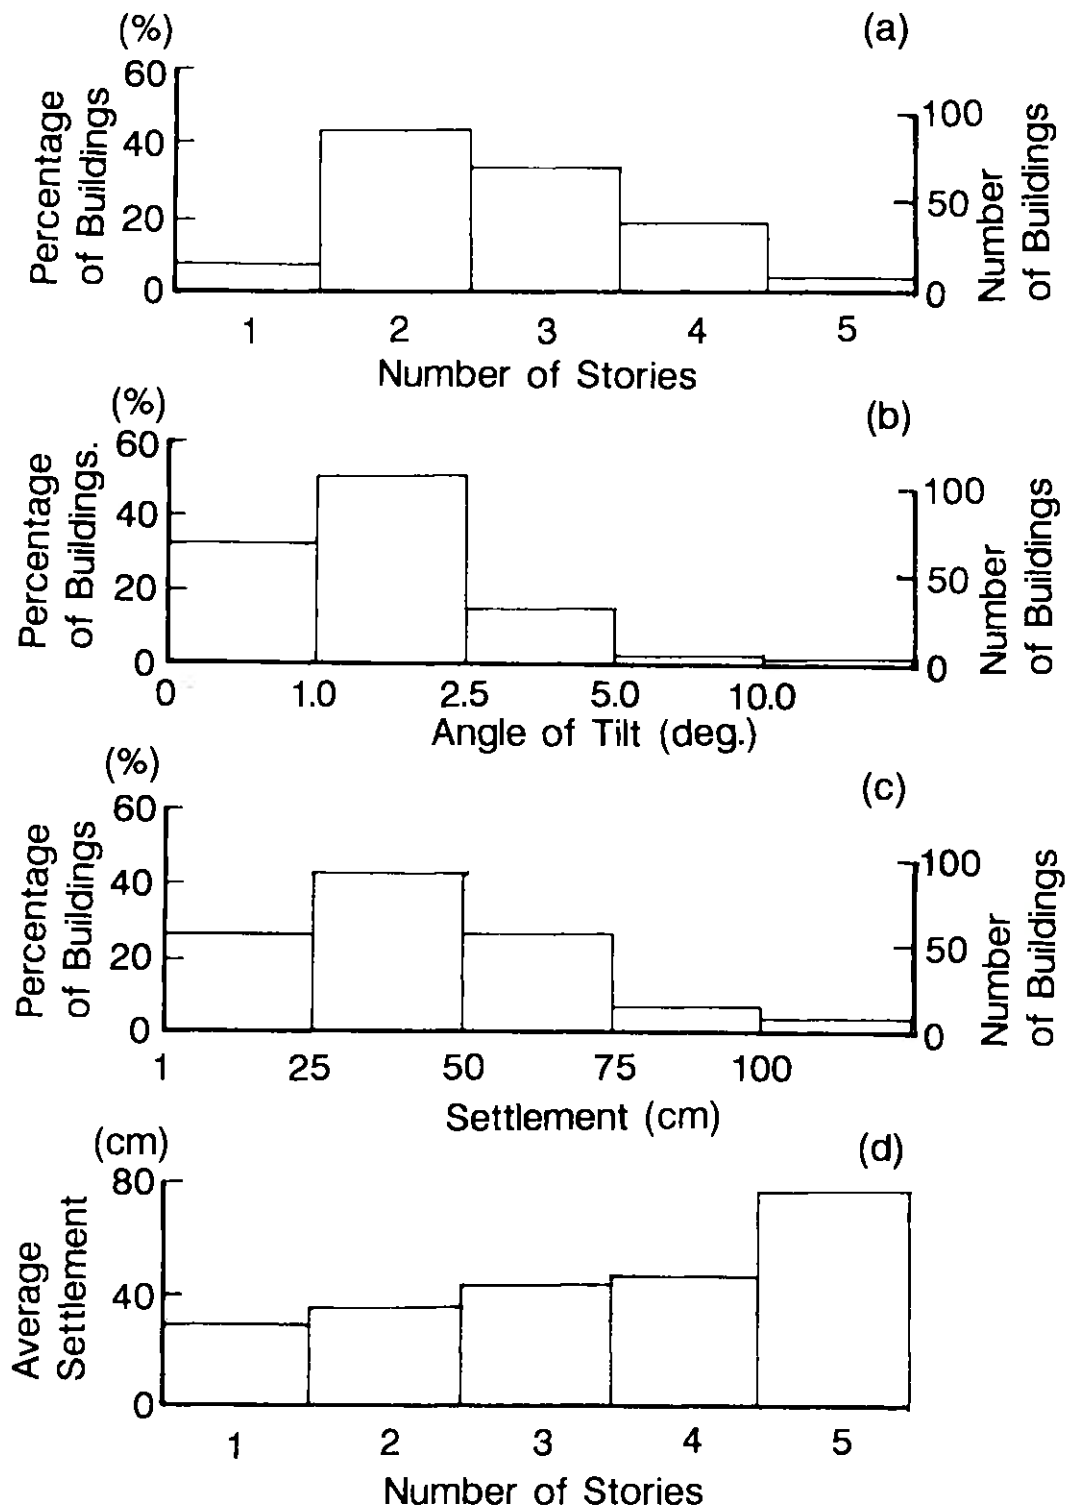
FIG. 4. Damage Statistics of Reinforced Concrete Buildings In Dagupan

inspected and located in the liquefied area. Most of the buildings are two- to four-storied with shallow footings [Fig. 4(a)]. Apparent lack of pile foundations for the buildings in the liquefied area shows that no consideration was made in the foundation design to mitigate liquefaction hazards. More than half of the buildings in the liquefied area tilted more than 1° [Fig. 4(b)]. The average settlement of the buildings relative to the ground surface is about 50 cm [Fig. 4(c)], and tends to increase with increasing number of stories [Fig. 4(d)].

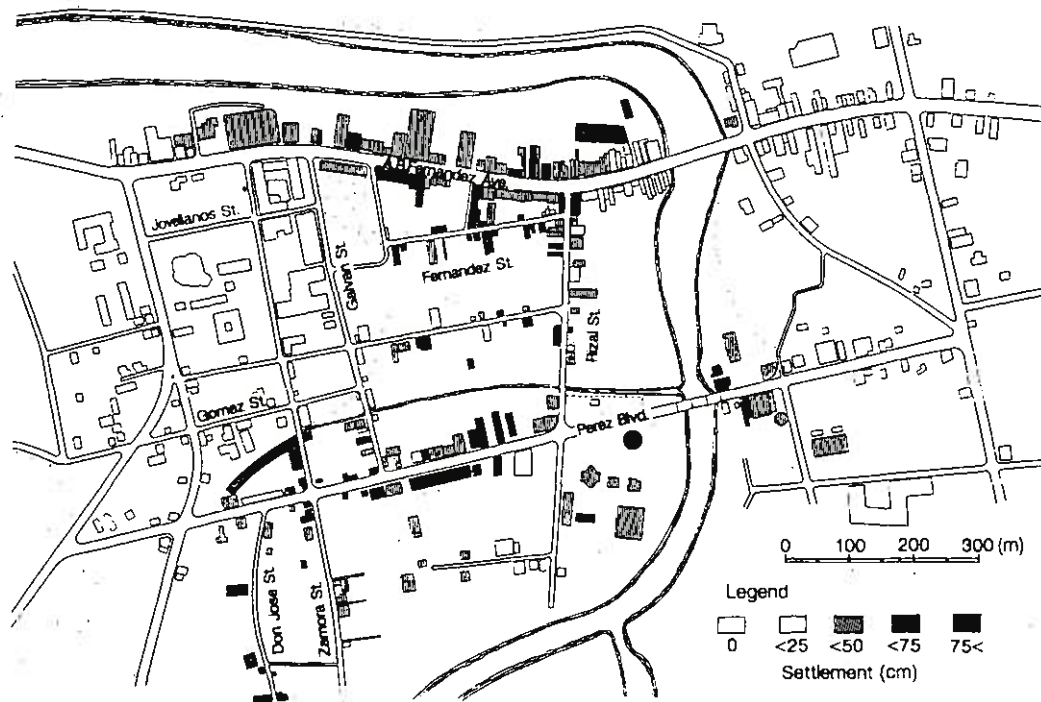
FIG. 5. Map Showing Settlement of Reinforced Concrete Buildings

Fig. 5 shows the distribution of the settlements relative to the ground surface of reinforced concrete buildings, and Fig. 6 shows the distribution of the damage to wooden houses. The damage to wooden houses is classified into one of four categories shown in the figure. Over two-thirds of the reinforced concrete buildings suffered severe damage on the west side of the Pantar river, whereas the buildings on and to the west of Galvan Street from Jovellaros Street to Gomez Street remained intact (Fig. 5). Many of the reinforced concrete buildings on Perez Boulevard, Fernandez Street, and Rizal Street between A. B. Fernandez Avenue and Perez Boulevard settled and tilted considerably, whereas those on A. B. Fernandez Avenue generally suffered smaller settlement and tilting. The damage to superstructure was, however, significant in many buildings on A. B. Fernandez Avenue. Several reinforced concrete buildings on Don Jose Street and Zamora Street south of Perez Boulevard suffered large settlement and tilting. Wooden houses in this area were also badly damaged (Fig. 6). The ground surface along Don Jose Street appeared to have settled as much as 50 cm, and had been inundated until a dry season. The liquefaction-induced damage was obvious within a limited area on the east side of the river. Only a limited number of the reinforced concrete buildings in the lateral spreading zone

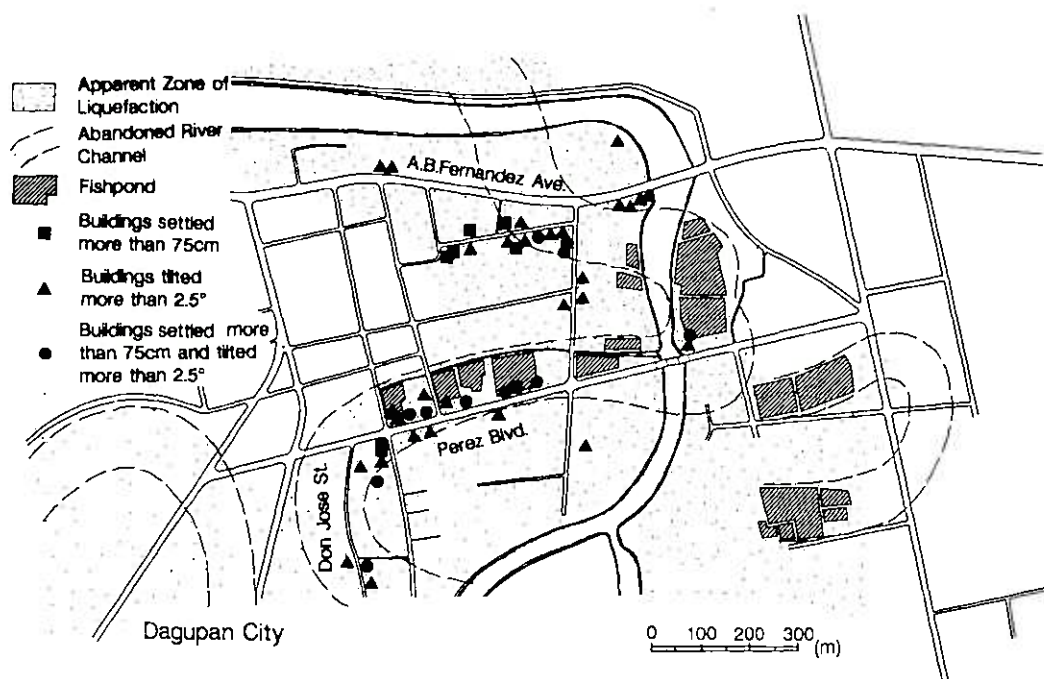
FIG. 7. Map Showing Effects of Geomorphological Conditions on Damage to Buildings

Fig. 7 shows the locations of recently abandoned river channels (Punongbayan and Torres 1990), fishponds, and swamps, all of which can be detected from aerial photographs taken in between 1966 and 1974. Much of the north side of Perez Boulevard was still either swamp or fishpond then. Superimposed on the figure are the locations of the buildings that settled more than 75 cm and/or tilted more than 2.5°. Most of the buildings concentrate in the recently abandoned river channels and in the banks of the active river. Several buildings on the north side of Perez Boulevard that settled and tilted considerably are found to have been located within the old fishponds. It is also found that the extensive damage to wooden houses and ground settlement along Don Jose Street are attributed to the fact that these areas are situated on fills in recently abandoned river channels. These findings confirm that geomorphological conditions have significant effects

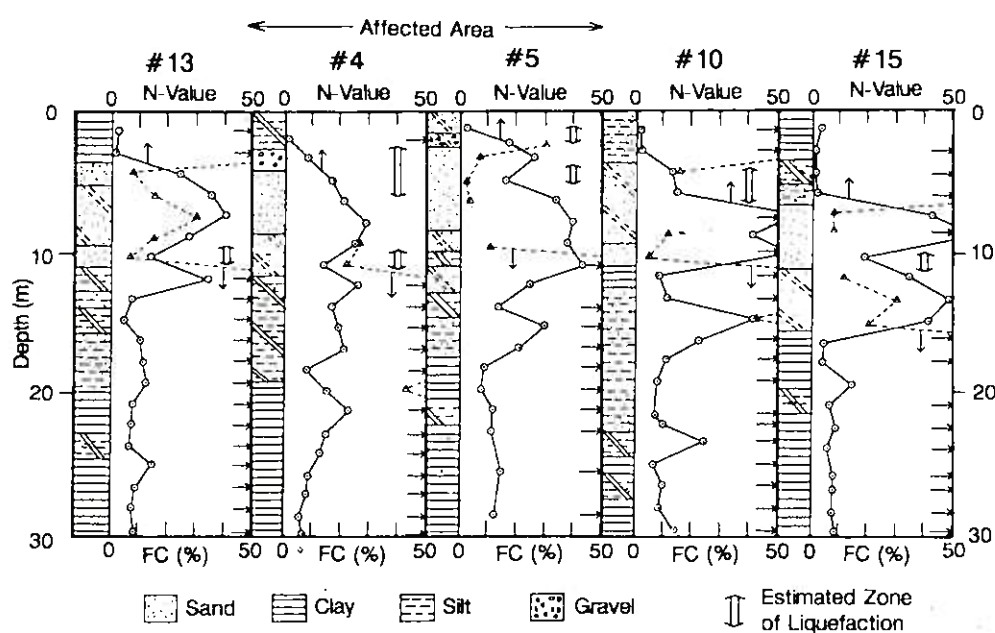
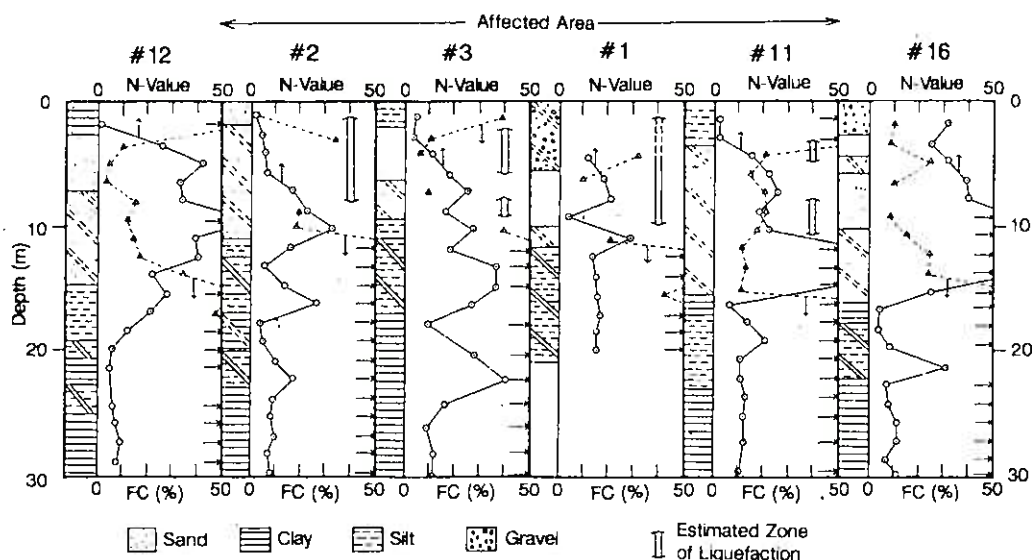
The standard penetration tests (SPT) were conducted in the city by the Department of Public Works and Highways before and after the earthquake. The location of the test sites is shown in Fig. 2. The boring logs along A. B. Fernandez Avenue (sites 13, 4, 5, 10, and 15) and Perez Boulevard (sites 12, 2, 3, 1, 11, and 16) are shown in Figs. 8 and 9. Also shown in the figures are SPT *N*-values and fines contents (FC). The SPT *N*-values at site 1 were obtained before the earthquake, while those at the other sites were determined within three months after the earthquake. In the affected area, where the reinforced concrete buildings settled more than 25 cm, the surface layer to a depth of 5–10 meters is predominantly sandy soil with SPT *N*-values less than 30. Underlying the surface layer is a layer of dense sand or stiff clay. In the unaffected area, in contrast, a layer of clay and/or dense sand

To investigate the effectiveness of the empirical chart in more detail, the layers that are estimated to have liquefied from at least one of the two methods, are indicated in Figs. 8 and 9. In the extensively affected area along the Perez Boulevard (sites 2, 3, and 1), almost all sand layers below the ground-water table to a depth of about 10 m are estimated to have liquefied, whereas only a part of the sand layers near the ground surface are estimated to have liquefied in the other affected area (sites 4, 5, and 11). This is consistent with the field observation that the structures along Perez Boulevard on the west side of the river settled and tilted more than the structures in the other liquefied area. The soil in the zone that experienced little or no damage (sites 10, 12, 13, 15, and 16) is estimated to have not liquefied or slightly liquefied, which also shows good agreement with the field observation. To confirm the aforementioned findings, the estimated thickness of liquefied layer at each site is plotted in Fig. 12 against the extent of damage to buildings at the site. The extent of damage is classified into one of four categories from A to D. Category A correspond to a site in the nonliquefied area with no structural damage, category B to a site near the boundary separating liquefied from nonliquefied zone with no structural damage, and categories C and D to sites in the liquefied area with considerable structural damage (average settlements of reinforced concrete buildings are less than 50 cm) and with vital structural damage (average settlements of reinforced concrete buildings are greater than 50 cm), respectively. At sites in categories A and B, the thickness of liquefied layer

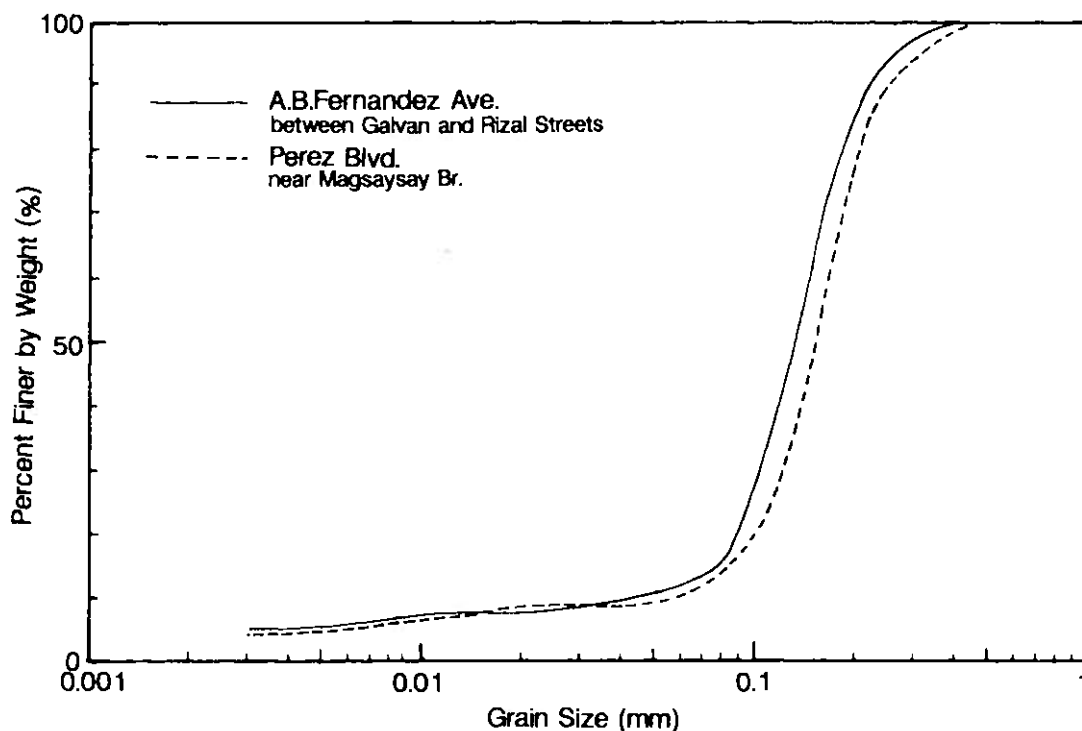
FIG. 10. Grain Size Distribution Curves of Sands

with SPT N -values greater than 30 exists from the ground surface. The grain size distribution curves for the boiled sands obtained in the city are shown in Fig. 10. The results of sieve analysis suggest that the liquefied sands are fine to silty sands having mean grain sizes of 0.1–0.2 mm. Thus, a part of the surface layer of fine to silty sands is considered to have liquefied, though their SPT N -values are somewhat higher than that generally expected for these sands [e.g., Seed et al. (1985)].

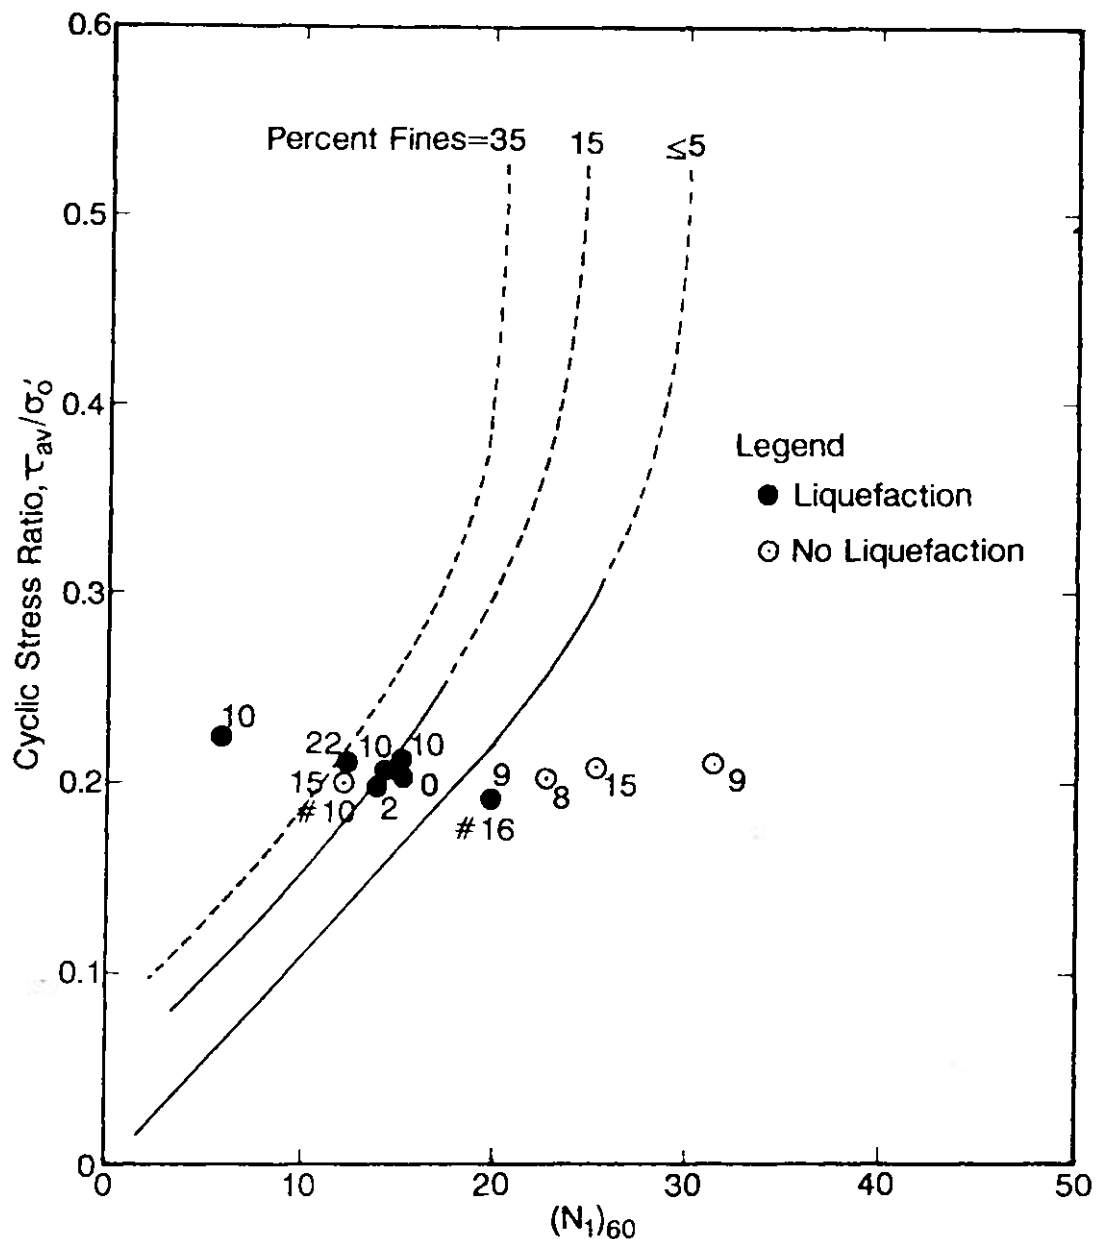
FIG. 11. Chart for Evaluation of Liquefaction Potential with Field Data from 1990 Luzon Earthquake (Numbers without # by Data Points Indicate Fines Content, and Numbers with # Indicate Site Number)

Fig. 11 shows correlations between estimated cyclic stress ratio and SPT $(N_1)_{60}$ at critical depths of all sites. Sites known to have liquefied are plotted

as solid circles, and sites that did not show any evidence of liquefaction are plotted as open circles. The number without # beside each symbol indicates fines content. Superimposed on the figure is the empirical chart developed by Seed et al. (1985), which separates liquefiable from nonliquefiable conditions. The field data are in fairly good accord with the chart, except two sites (10 and 16), which are located near the boundary separating liquefied from nonliquefied area, as shown in Fig. 2.

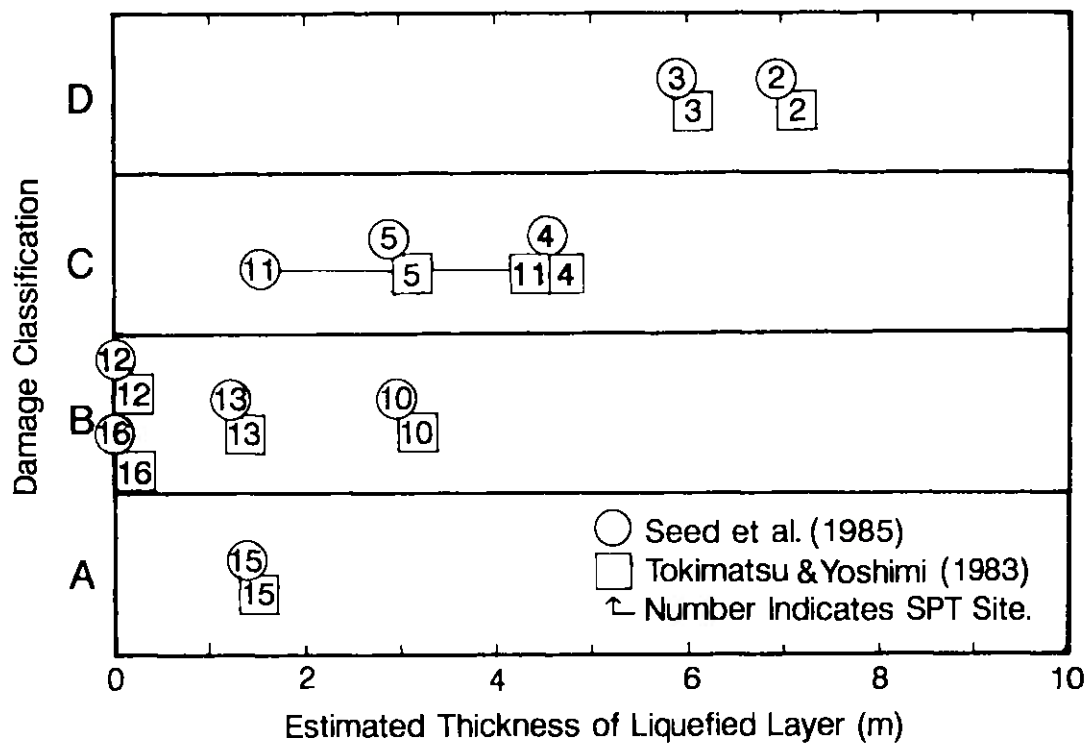
FIG. 12. Correlation of Estimated Thickness of Liquefied Layer with Damage Classification of Buildings

is less than 3 m. In contrast, at sites in categories C and D except site 11, it is larger than 3. Besides, the thickness of liquefied layer tends to increase with increasing extent of damage to buildings. Thus, the empirical correlations using SPT N -values appear to be able to estimate not only the occurrence of liquefaction but also the extent of resulting damage, with a reasonable degree of reliability.

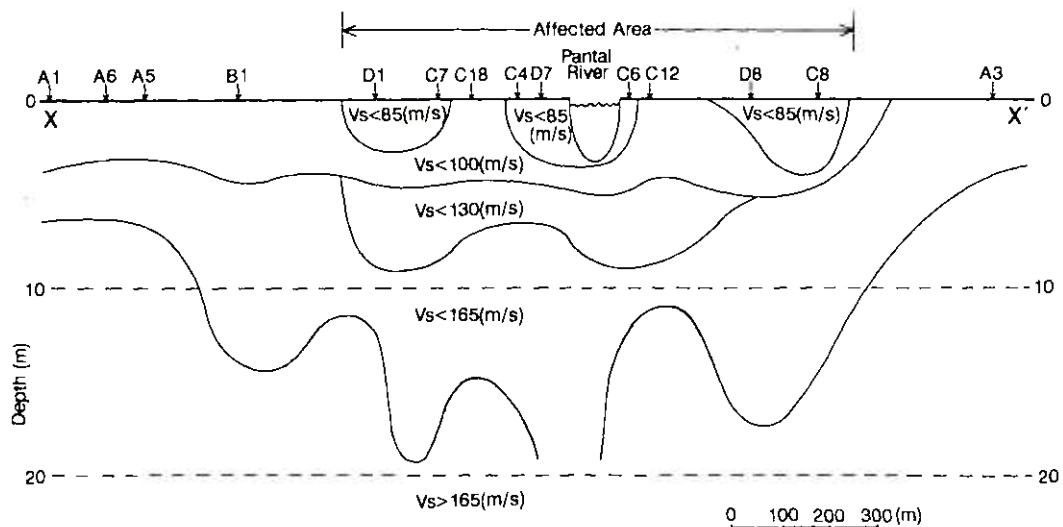
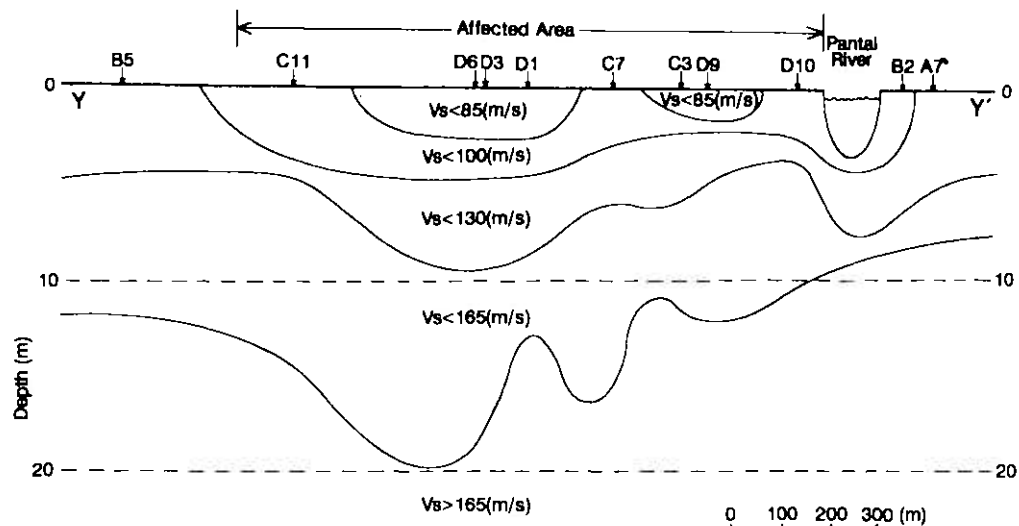
damage to structures at each site is classified into four categories from A to D cited previously, and the site is labeled accordingly. Figs. 14 and 15 show cross sections of V_s structure along $X-X'$ and $Y-Y'$ lines shown in Fig. 13. The V_s profiles in the affected area contrast well with those in the unaffected area in the following manners. The shear wave velocity of the top layer is less than 85 m/s in the severely affected area, and more than 85 m/s in the other area. Comparison of Figs. 13 and 14 with Fig. 7 further reveals that the soft surface layer with V_s less than 85 m/s occurs only near the active river and on recently abandoned river channels. In much of the affected area, the layer with V_s less than 130 m/s exists to a depth more than 5 m. In the unaffected area, in contrast, such a layer with V_s less than 130 m/s exists generally at depths smaller than about 5 m. In the affected area, a stiff layer with V_s greater than 165 m/s occurs generally at depths greater than 12 m but in the unaffected area at depths less than 8 m. A similar tendency can be seen at all test sites as summarized in Fig. 16, in which both the depths to layers with $V_s \geq 130$ and ≥ 165 m/s tend to increase as the extent of damage to buildings increases.

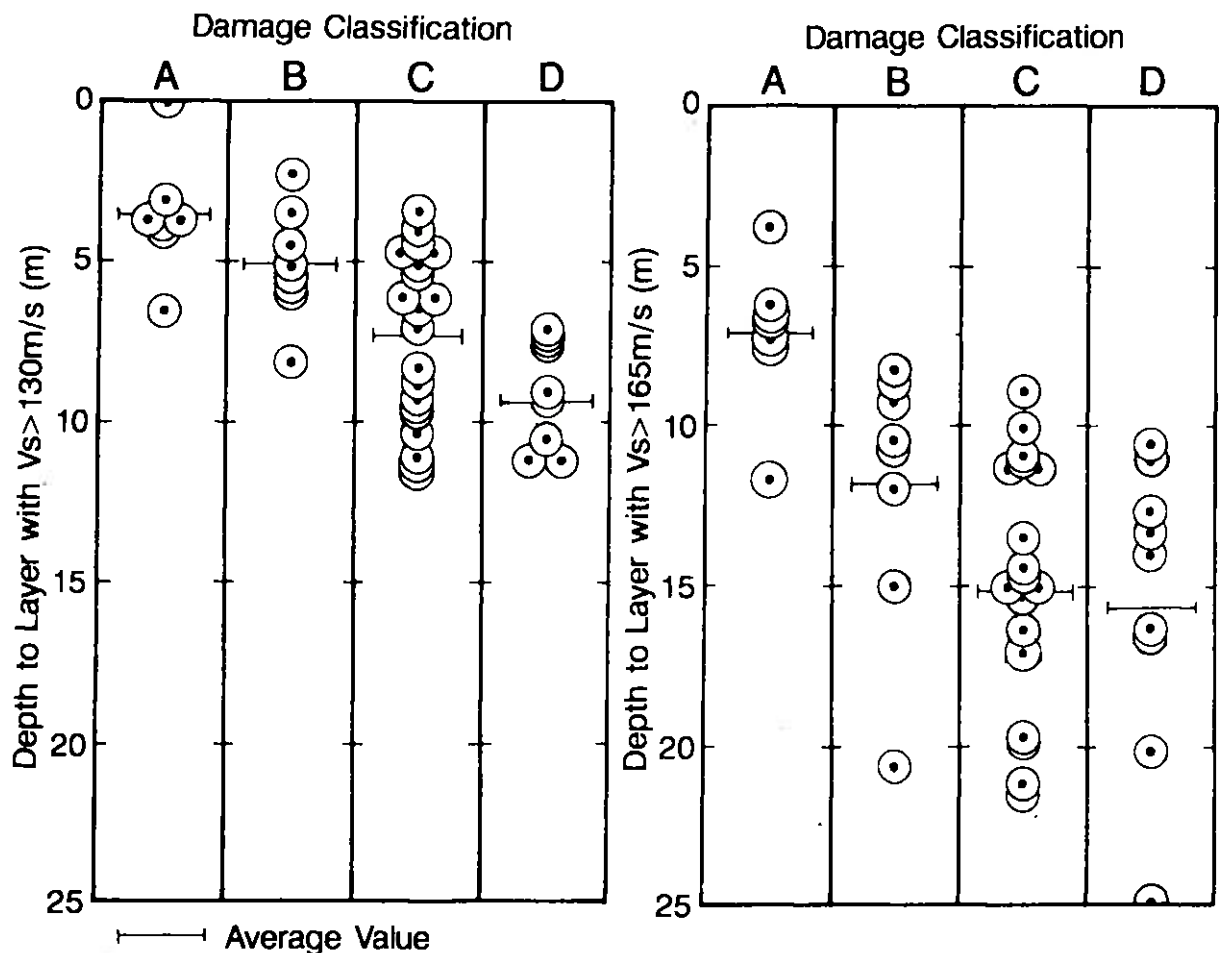
FIG. 16. Depths to Layers with $V_s > 130$ and 165 m/s

Comparison of Figs. 13 and 16 with Figs. 8 and 9 suggests that the layer with V_s less than 130 m/s corresponds to either the surface clay layer or the sand layer with SPT N -values less than 30. The layers with V_s greater than 165 m/s are likely to correspond to the clay layer that underlies the sand layer and/or the sand layer with SPT N -values greater than 30. The reasonably good agreement of the V_s profiles with the available information suggests that the Rayleigh wave method used shows capability in characterizing two- or three-dimensional V_s structures of near-surface soils.

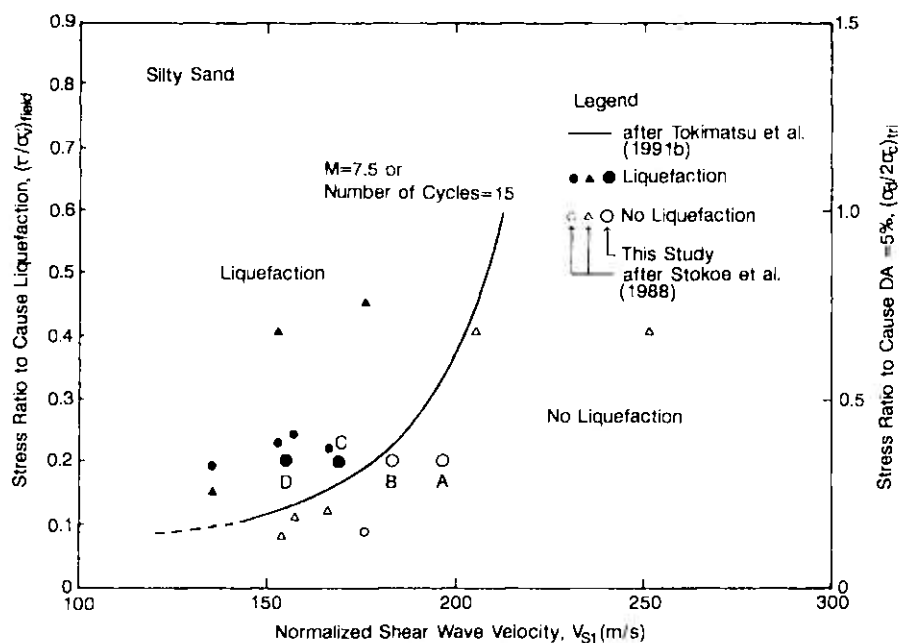
FIG. 17. Relation between Stress Ratio Causing Liquefaction and Normalized Shear Wave Velocity

From Figs. 13–16, representative values of shear wave velocities at a critical depth of 5 m are 140, 130, 120, and 110 m/s for categories A to D sites, respectively. Based on these values, the relation between the normalized shear wave velocity and the stress ratio corresponding to $M = 7.5$ conditions at the critical depth of four category sites were estimated, and are plotted in Fig. 17. Also shown in the figure are the data from the 1979 Imperial Valley ($M_s = 6.5$) and 1981 Westmorland ($M_s = 5.6$) earthquakes (Stokoe et al. 1988) for which correction has been also made to the stress ratio to allow for the difference in earthquake magnitude. The proposed chart is consistent with the field observation, indicating its potential usefulness, though further field verification is evidently needed.
