A NEW BUILDING INFLICTED BY THE KOBE EARTHQUAKE OF JANUARY 17, 1995 AND THE MEASURES TAKEN TO RESTORE AND STRENGTHEN THE FOUNDATION-BUILDING SYSTEM

Kenya Harasawa,¹⁾ Madan B. Karkee²⁾ and Hideaki Kishida³⁾

A new building in the city of Nishinomiya, near Kobe, was just ready for hand over when the January 17, 1995 earthquake occurred. The building looked structurally intact, but the piles supporting it were found to have been completely damaged. A comprehensive plan involving a tricky simultaneous operation of 61 hydraulic jacks was developed and successfully implemented to jack-up and restore the foundation-building system. Luckily, there were no aftershocks closer in size to the main event during the implementation phase. The differential settlement and tilting were practically nil when the restoration was complete. The experience gained from the project is vital in future restoration and reconstruction of pile foundations damaged by extreme earthquake events.

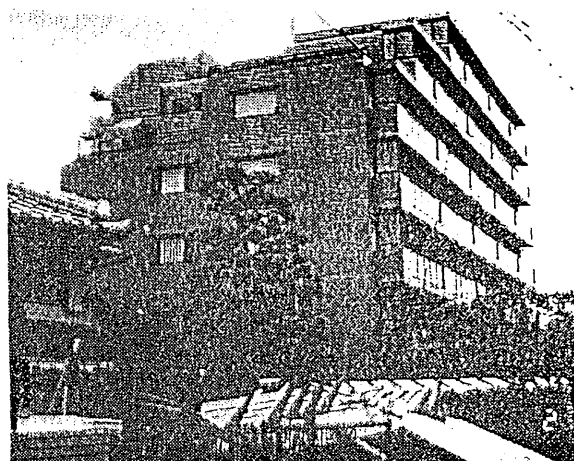
From the initial visual inspection immediately after the earthquake, the structure was thought to be practically unscathed as seen in Figure 5. However, there were some non-structural cracks visible along the corridor and on the verandah side such as shown in Figure 6. Also the collapsed boundary wall in the side of the building can be seen in Figure 6, where a photograph taken from the entrance shows the cracking of paved surface. Some ground settlement can also be noted.

Figure 5: View of Seemingly Undamaged Building

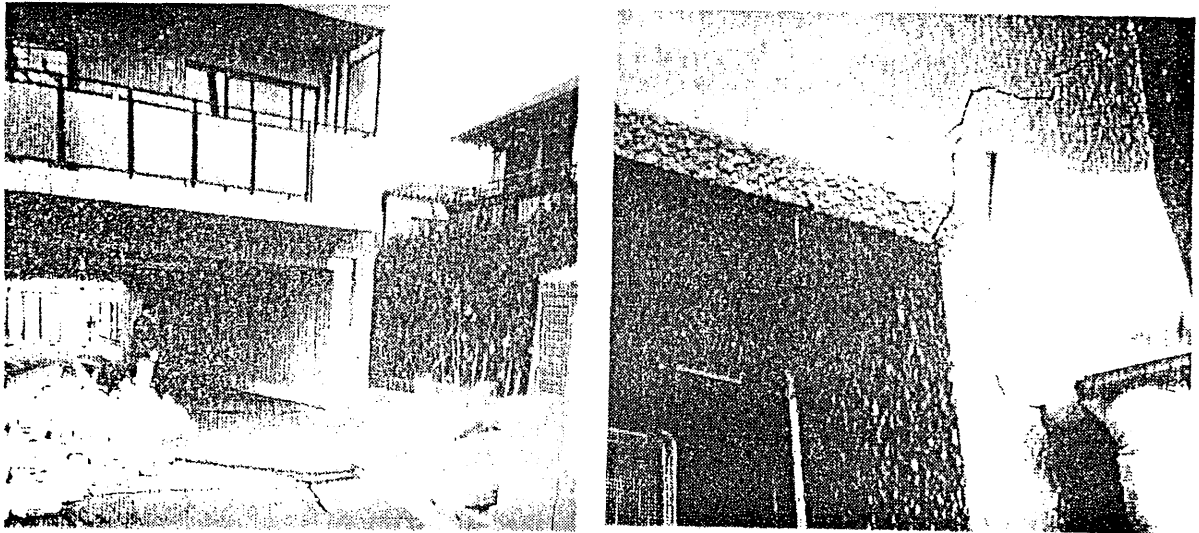
Figure 6: Cracking of Paved Surface, Collapse of Boundary Wall and Cracking of Non-structural Wall Observed after the Earthquake

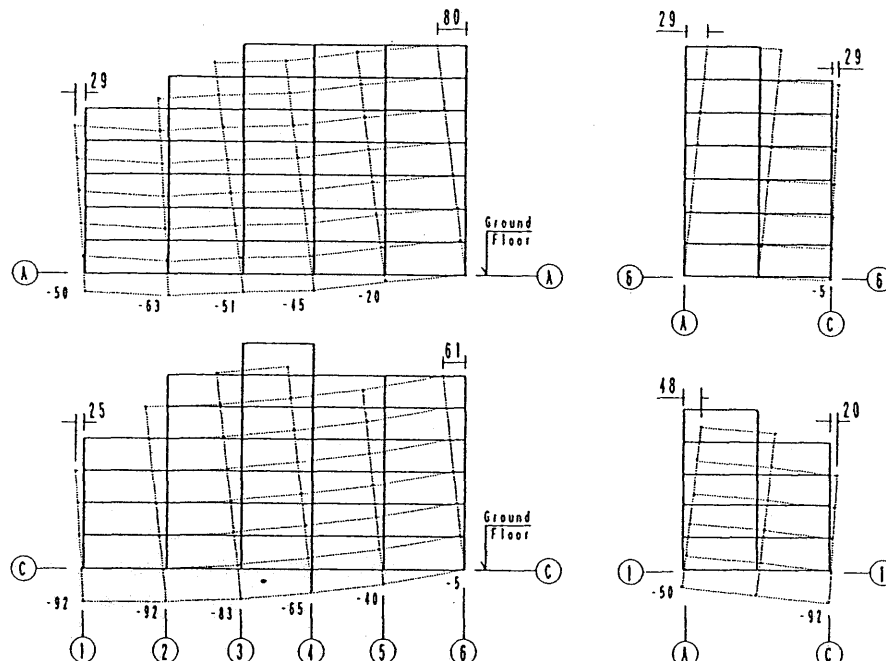
Figure 7: Illustration of the Nature of Differential Settlement and Tilting of the Building Based on the Detailed Measurement and Investigation.

Detailed measurements were made subsequently. The location map of boreholes in Figure 8 shows the temporary bench mark (TBM), relative to which settlements were measured. It was revealed that there was a differential settlement of about 90mm between eastern and western ends of the building, as seen in Figure 7. Note that the grid-line numbers given in Figure 7 correspond to those shown in the foundation plan in Figure 3. It was found that the south-east corner (A-6 in Figure 3) of the roof was out of the plumb-line by about 80mm as seen in Figure 7. It was inferred that such significant differential settlement and tilting of the building meant that the pile foundation supporting the structure must have incurred substantial damage. Skeletal frame analysis was carried out to evaluate the forces and moments exerted in different members due to the measured settlement and tilting of the building superstructure. This provided with a grasp of the existing state of stresses in the

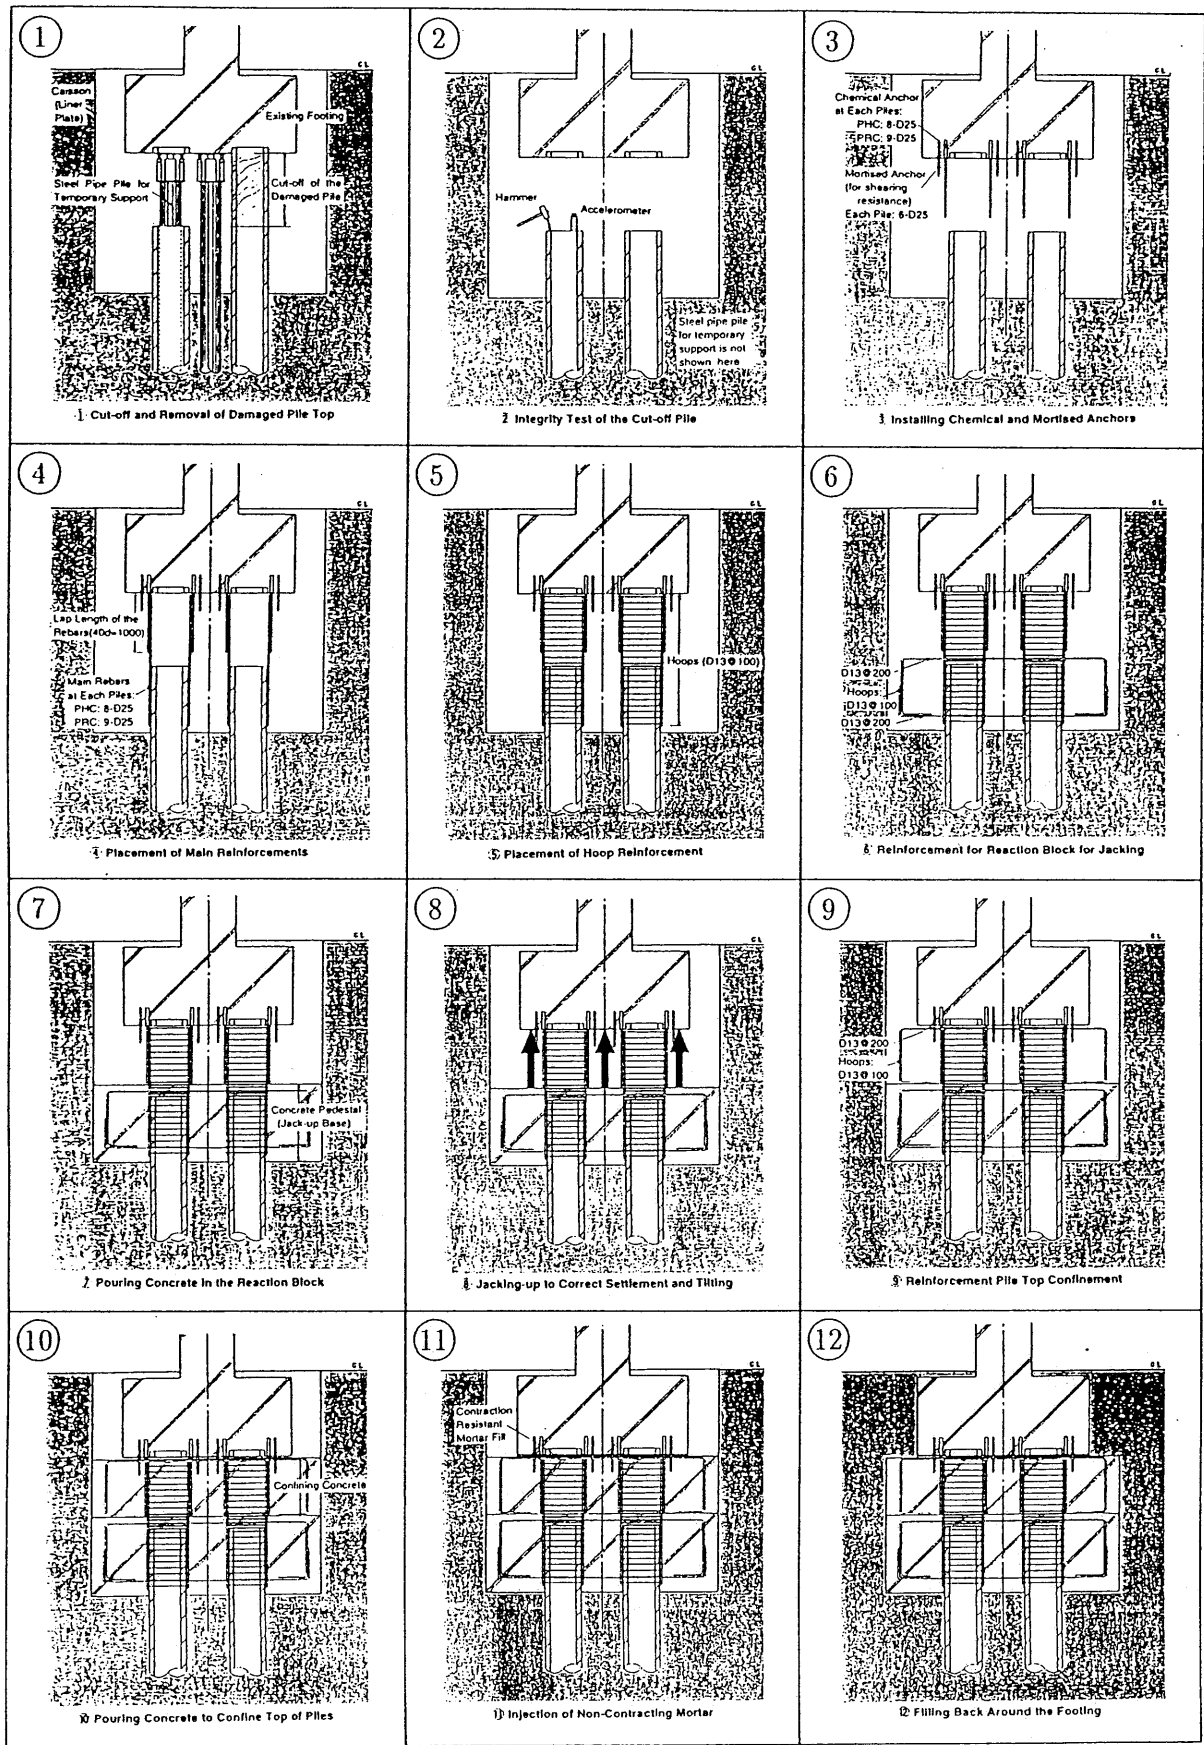
Figure 10: Diagram Illustrating Typical Underpinning and Repair Sequence for Restoration. (Note: To avoid obscurity, subsequent steps do not show steel pipe piles.)

After a steel pipe pile was installed to have the required bearing capacity, part of the load from the footing was transferred to it and the damaged portion of the precast concrete pile was cut-off and removed as shown in step 1 in Figure 10. The nature of damage of all the piles were recorded, and is discussed in the following section. The lower part of the cut-off pile was tested for integrity as seen in step 2 of Figure 10.

For connection of the cut-off piles to the footing, chemical anchors for main reinforcement and mortised anchors for shear connection were installed (step 3) at the underside of the footings. As seen in step 4, the main reinforcement for the connection were placed to have an appropriate lap-length with the chemical anchors. Then the hoop reinforcements were placed as shown in step 5 in Figure 10. After that, the reinforcement for the concrete reaction block (pedestal) were placed (step 6) and concrete was placed (step 7). Note that the steel pipe piles actually taking the footing load are not shown in subsequent steps in Figure 10 for clarity of diagrams.

Installation was carried out at all the footings up to step 7, so that the simultaneous jacking-up operation described below could be undertaken. It was found that all the piles supporting the building had failed except for the six numbered 29 to 34 in Figure 3, where the steel pipe piles can be noted to be absent in footings 6A, 6B and 6C. Once the building structure was jacked up (step 8 in Figure 10) against the reaction blocks to correct for differential settlement and tilting, further reinforcements were placed on top of the reaction block (step 9) and concrete was poured (step 10) to confine the top of piles. The jacking operation is discussed in more detail below. Finally, non-compressible mortar was injected below the footing (step 11) so as to transfer the footing load to the confining concrete block below, and the excavation was filled back (step 12).

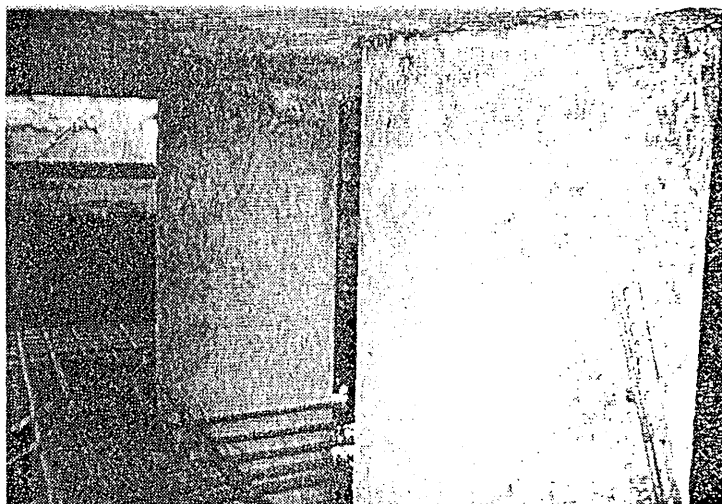
As mentioned above, the six piles along grid-line 6 on the east side of the building were found to be intact. It can be noted from Figure 7 that the settlement along this grid-line measured relative to the TBM in Figure 8 is also quite small. Figure 11 shows the top of two piles under footing C6, which are numbered 29 and 30 in Figure 3. It can be noted that the piles are undamaged. The piles under the other two footings in grid-line 6 were similarly intact.

Figure 11: Example of Undamaged Pile

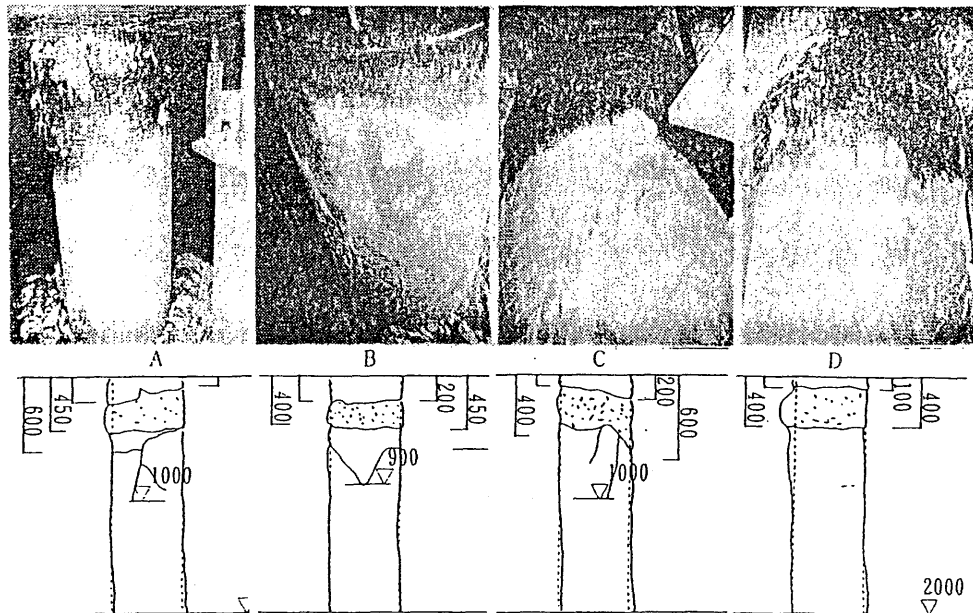
Aside from the six, all the other piles had failed in some sort of a combination of shearing and compression mode. The conditions of a PRC pile numbered 4 in Figure 3, is shown in Figure 12. Photographs taken from four mutually perpendicular sides (denoted as A, B, C

and D sides) together with rough sketches of the damage size in each case are shown for pile 4. Similarly, Figure 13 shows by photographs and sketches the damage to a PHC pile, which is numbered 25 in Figure 3.

Figure 12: Photographs and Sketches of the Four Mutually Perpendicular Sides of the Top of a Typical damaged PRC pile

It may be noted that the PRC pile of Figure 12 is located on the side of the building where the settlement is largest, while the PHC pile of Figure 13 is located next to the grid-line of minimum settlement (eastern end of building). However, the damage in the PHC pile can be noted to be much more severe compared to that in the PRC pile. The reason most likely lies in the relatively higher ductility of the PRC pile. Brittle nature of the failure initiated by shearing crack and subsequent crushing in compression was noted in case of all the PHC piles.

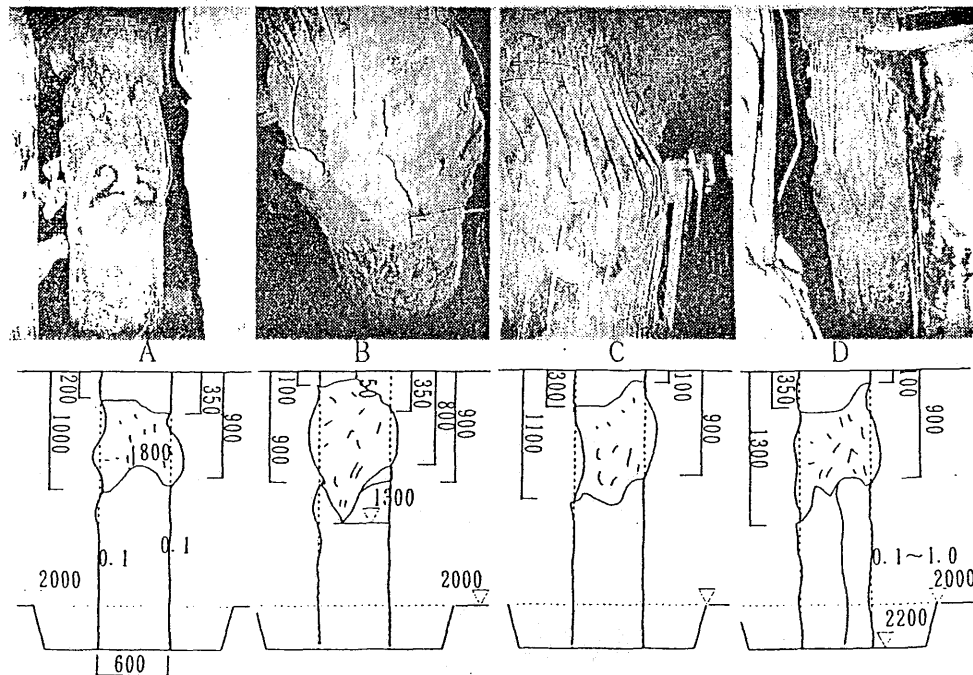
Figure 13: Photographs and Sketches of the Four Mutually Perpendicular Sides of the Top of a Typical damaged PHC pile

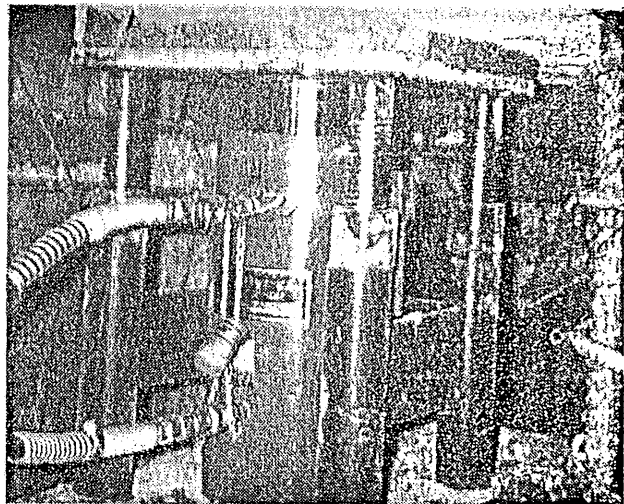
Figure 15: Photograph of a Typical Set-up During the Jacking-up Operation.

The jacking-up process involved the use of a hydraulic distribution system simultaneously operating 61 hydraulic jacks. The layout plan of the hydraulic jacks of capacities 1.5MN, 1.0MN and 0.5MN (numbering 18, 34 and 9 respectively) are shown in Figure 14, where the hydraulic jacks of different capacities are represented by different notations. Two pumps were utilized to operate the jacks through a hydraulic distribution system shown in Figure 14. A typical situation of jacking-up operation can be seen in the photograph of Figure 15.

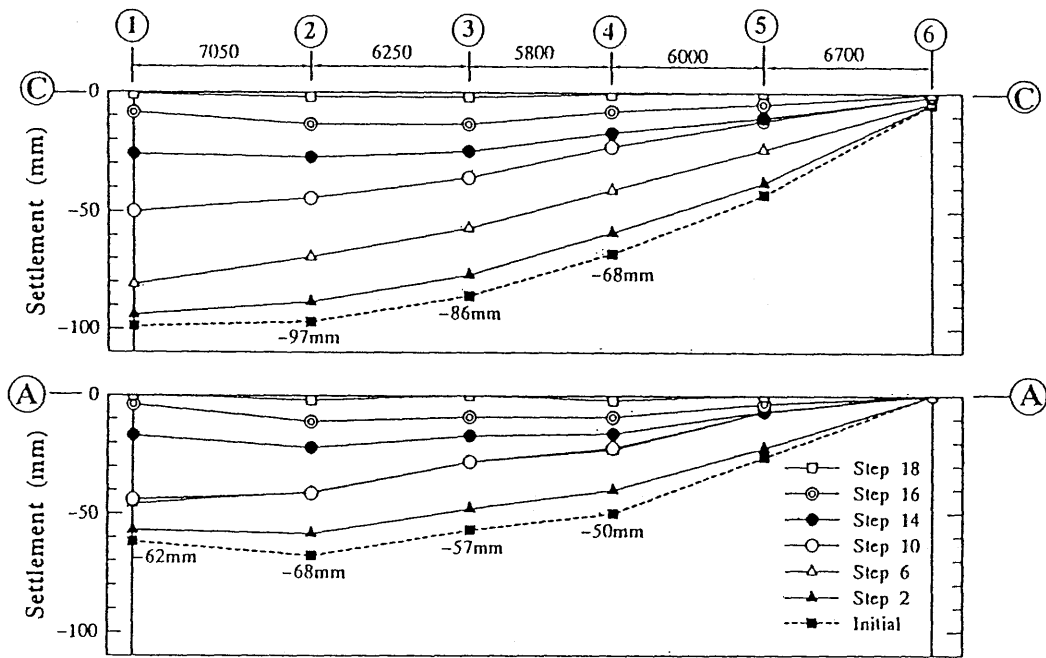
Figure 16: Reduction in the Settlement of the Building at Different Stages of the Jacking-up Operation

The jacking-up operation was carried out in small steps with close monitoring of level at all the footings, as well as the extent of recovery of the tilt of the building. There were altogether 18 steps. Figure 16 shows the extent of the recovery of the differential settlement of the building along grid-lines A-A (south) and C-C (north) at selected steps of jacking-up operation. The dotted line shows the existing settlement, and the differential settlement can be seen to decrease steadily as the jacking-up operation continued. After the end of the final step, the differential settlement can be noted to be practically negligible.
