# COMMON BEHAVIOR OF BUILDING FOUNDATIONS DURING THE HYOGOKEN-NAMBU EARTHQUAKE

Madan B. KARKEE    Manager of Development Division, GEOTOP Corporation, Tokyo  
Koushiro NAGAI    Professor, Setsunan University, Osaka, Japan  
Hitoshi OGURA    Technical Coordinator, GEOTOP Corporation, Tokyo, Japan  
Hideaki KISHIDA    Professor, Science University of Tokyo, Shinjuku-ku, Tokyo

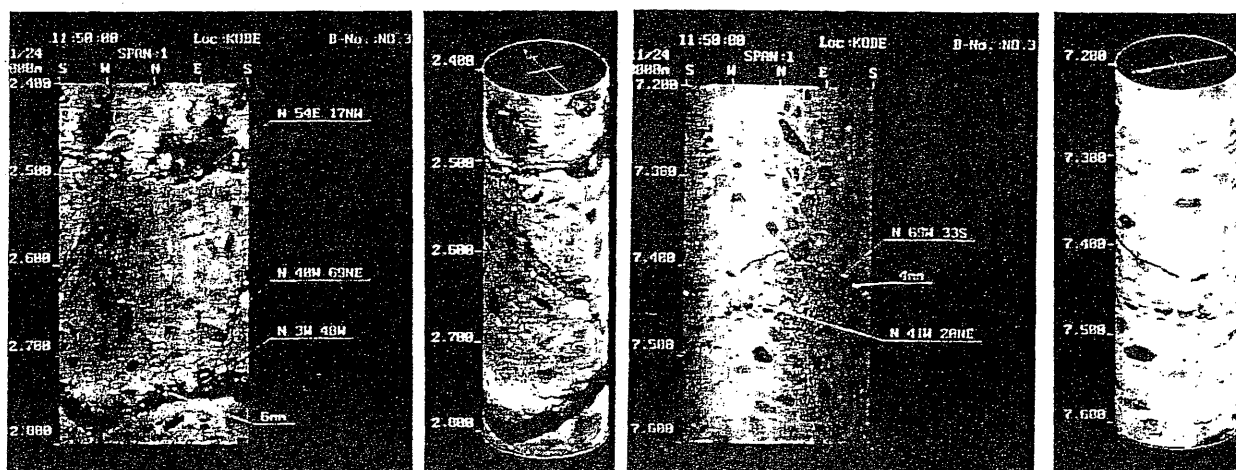
As noted above, most of the foundation damage occurred in buildings with less severe structural failure. Consequently, the confirmation of some sort of foundation damage did not result from excavation after demolition of the damaged superstructure. It was necessary to check the integrity of foundations under the existing buildings using the usual techniques such as digging in for direct inspection, sonic integrity testing, other sounding methods etc. as well as more advanced techniques such as the use of borehole camera. Figure 7 shows the example of cracking in a drilled shaft identified by borehole camera inserted into a cored hole.

Figure 7: Cracking in a Drilled Shaft Identified by Borehole Camera

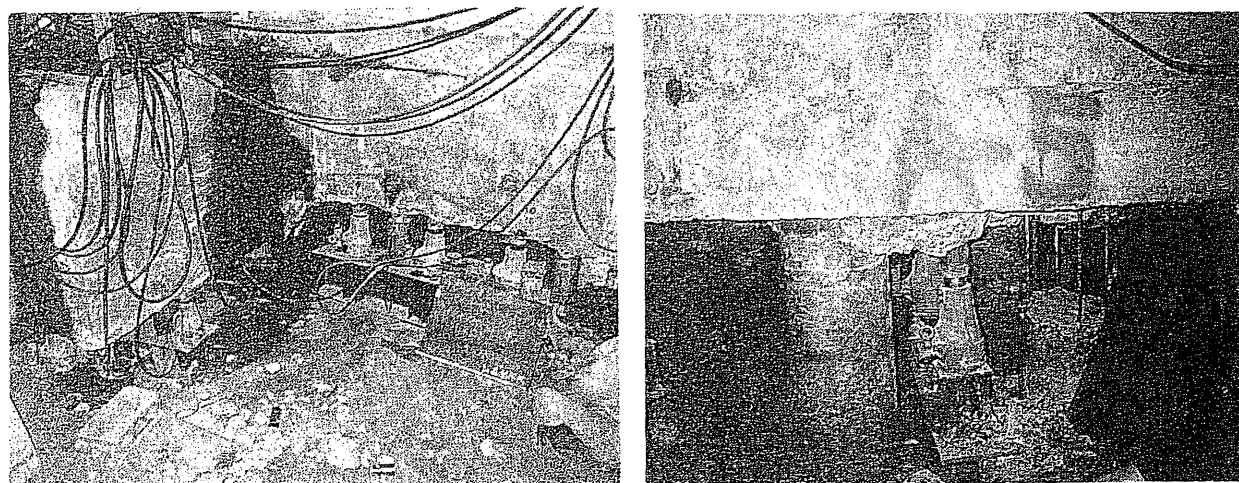
Figure 8: A Typical Scene of Jack-up and Repair of a Building with Damaged Pile Foundation

When the foundation damage is identified in buildings with little or no structural damage, it is logical to think of ways to rehabilitate the structural system by repairing and strengthening the foundation-structure system. There were several such rehabilitation projects carried out in and around Kobe (e.g. Harasawa, Karkee & Kishida, 1996). In cases where there was significant tilting and differential settlement, the buildings were jacked up to plumb and level before the load was finally transferred to repaired and strengthened foundation. A typical scene of jack-up and repair scene in a building with damaged pile foundation is shown in Figure 8.

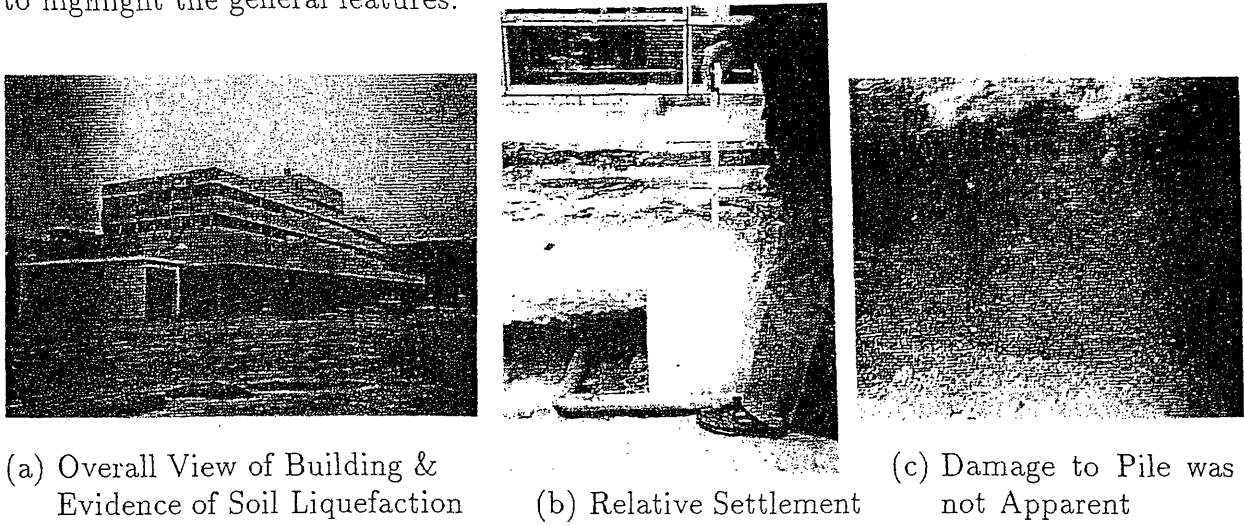
Figure 9: Example of  $\phi 500$  SC-PHC Pile (35 ~ 42m long) in Liquefied Reclaimed Ground

Figure 9 shows the instance of a combination of SC (steel encased concrete) pile at top and PHC (prestressed high strength concrete) pile at the lower portion to support a 4 storied RC building in a liquefied reclaimed ground. There was, however, no evidence of lateral ground spreading as a result of soil liquefaction. No clear evidence of pile damage was apparent in spite of about 750mm ground settlement relative to the building plinth.

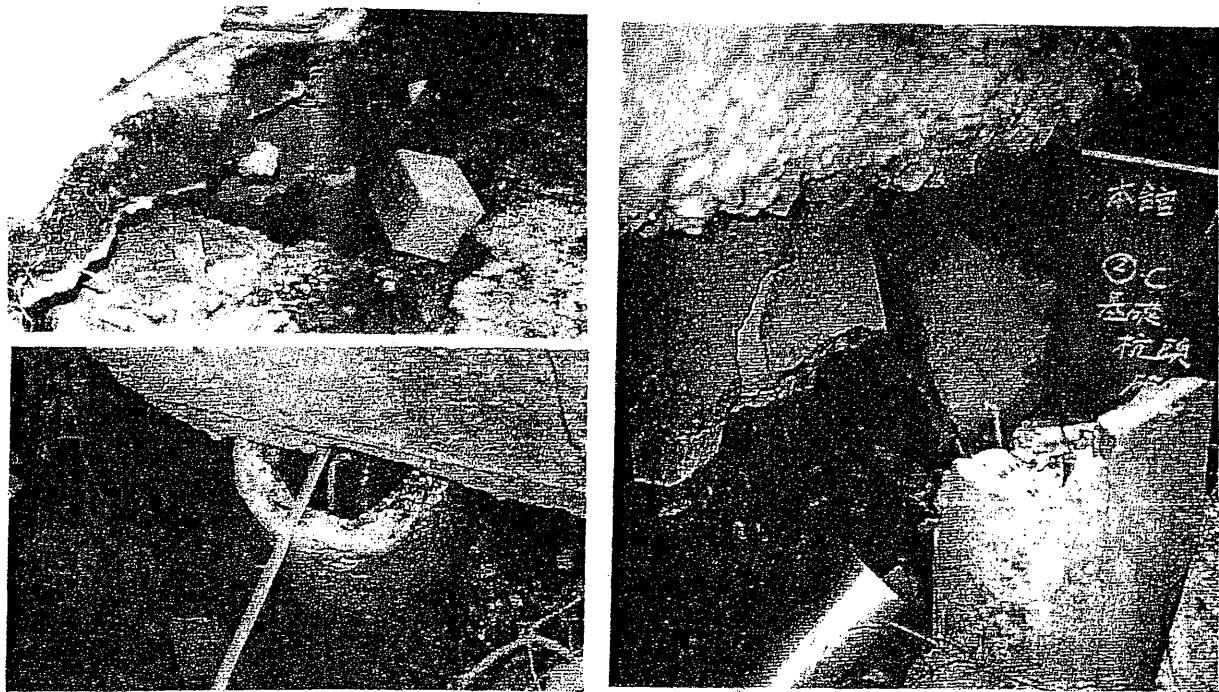
Figure 10: Examples of Precast Concrete Piles in Ground with Significant Lateral Spreading

Figure 10 shows the severity of the effect of significant lateral ground movement on the piles. Figure 10(a) shows the case of a 14m long RC (reinforced concrete) pile supporting a 2 storied steel structure in a reclaimed site about 20m from the quay wall. There was extensive settlement and lateral spreading due to liquefaction. Ground settlement of the order of 60 ~ 100cm was observed. The RC pile was completely broken off, most likely due to the lateral ground movement. Similarly, Figure 10(b) shows the failure of a PC (prestressed concrete) pile of unknown length supporting a 6 storied concrete building in ordinary ground. The building was located about 10m from the quay wall. The ground settlement was of the order of about 200cm primarily caused by seaward movement of ground. As can be noted in Figure 10, pile damage at location with significant lateral ground movement were very severe indeed.

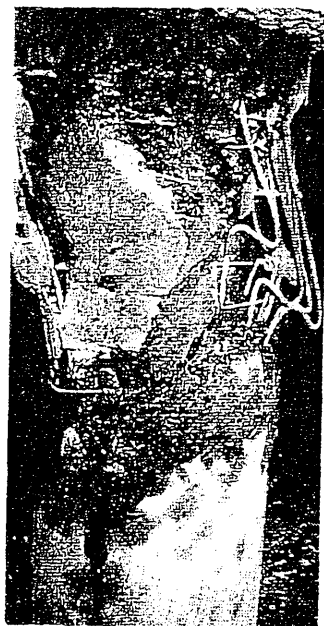
(a)  $\phi 500$  13m PHC Pile

Figure 11 shows the typical cases of pile foundation damage in fairly firm natural ground where there was no clear evidence of ground failure. Figure 11(a) shows the typical case of the damage to a PHC pile. The PHC pile supporting a 5 story RC building is seen to be completely damaged near the top probably due to the severe ground shaking followed by inertial forces from the superstructure. The building structure had tilted by about 1 in 120 but otherwise was quite intact, falling into the category of 'slight damage' mentioned in Figure 1.

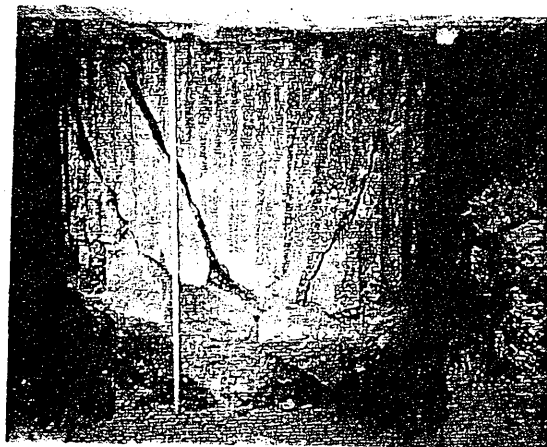
(b)  $\phi 1200$  12.5m Drilled Shaft Supporting a 11 Storied SRC Building Structure

Figure 11(b) shows the damage to a drilled shaft near the top in similar situation. However, in this case the SRC (steel and reinforced concrete composite) building structure was found to suffer extensive damage accompanied by a rather precarious tilting of about 1 in 30. Similarly, Figure 11(c) shows the case of a steel pipe pile (15m and 7.5m long) supporting a 10 storied RC structure. The first story columns of the building were found to have damaged due to a combination of shearing and compression action. The underside of the column footings were excavated for inspection. Damage to steel piles was not clearly apparent, but some lateral ground movement could be discerned, apparently due to inertial forces of the structure during severe ground shaking.

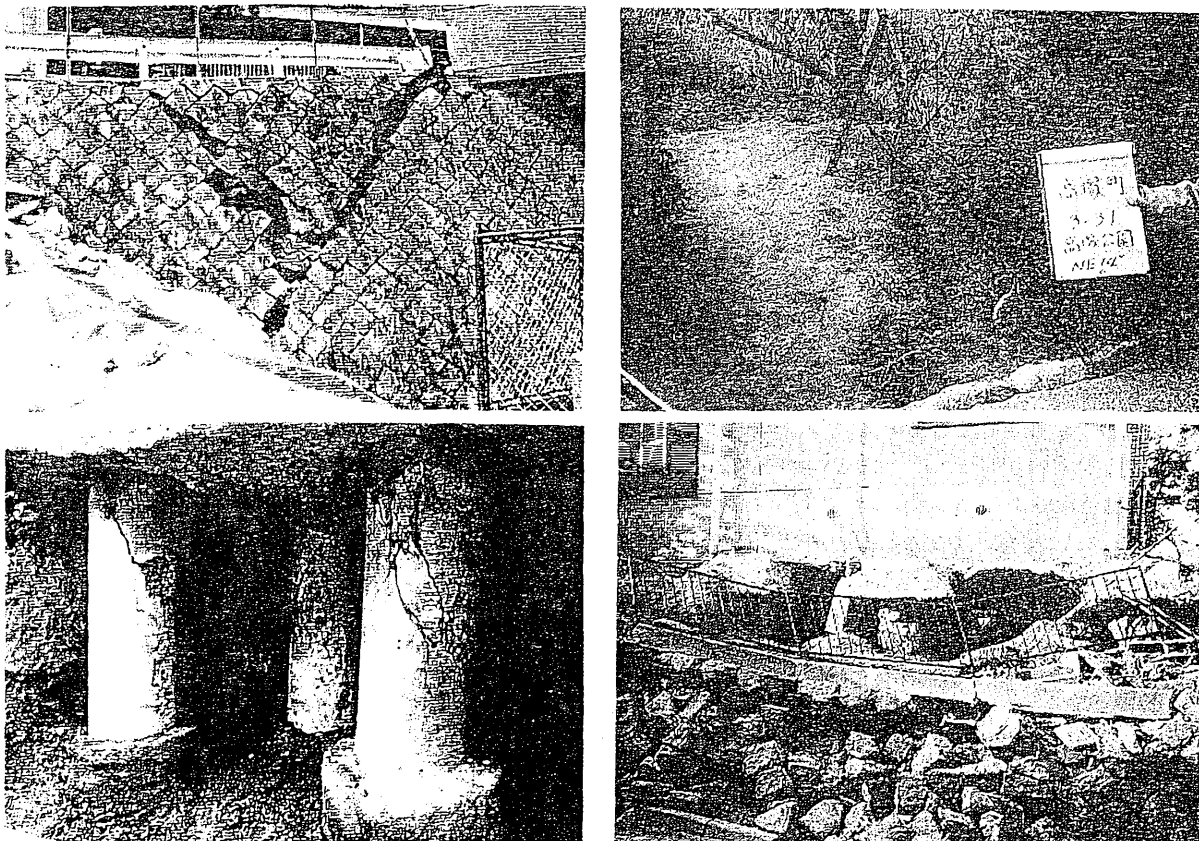
Figure 12 shows typical cases of foundation failure in sloping natural ground conditions where large movement occurred due to slope failure or other reasons. Figure 12(a) shows the damage in a PC pile and the cracking in the retaining wall indicating slope failure. Extensive bending-shear cracks as wide as about 10mm were observed within the top 60cm of the piles under the footing. The reason for the damage is most probably related to the complex soil layering system at the site accompanied by cut and fill operations to facilitate the relatively large scale construction consisting of the four buildings at the site.

Figure 12(b) shows the case of a PHC nodular pile supporting a small scale residential building complex in the hilly area to the east of Kobe city. The pile foundation was completely detached over part of the building structure that had tilted by about 1 in 150. PHC nodular piles are precast high strength concrete piles consisting of nodules at fixed intervals to enhance shaft resistance. The specification of the diameter as  $\phi 440 - 300$  in Figure 12(b) means a pile axis diameter of 300mm with diameter at the nodules of 440mm. These piles are probably not known well outside Japan, but are often used as friction piles in Japan (Kanai, Ogura and Sumi, 1996).

(a)  $\phi 350$  5.0m Long PC Pile Supporting a 7 Storied Framed Structure

(b)  $\phi 440 - 300$  PHC Nodular Pile Supporting a 3 Storied Apartment

Unlike the nature of slope failure in Figure 12(a), it is reported (GEOTOP, 1996) that the ground failure shown in Figure 12(b) is due the existence of a fault (known as Koyo fault) that is passing right through where the structure is located. A typical crack visible on the ground surface close to the building, allegedly due to the movement of the Koyo fault, is also shown in Figure 12(b). It is apparent that the substantial movement of sloping ground, whether due to slope failure or due to fault movement, can cause severe damage to pile foundations.

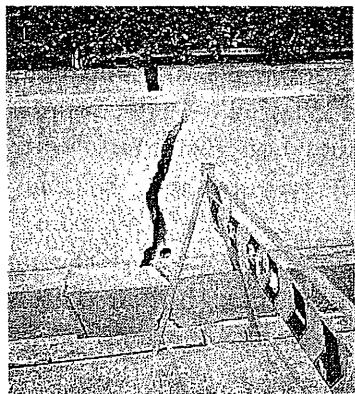
Figure 13 shows a 26m long  $\phi 500$  PC pile foundation supporting a 11 storied SRC structure that was evidently damaged due to extensive ground cracking to the north of the building due to displacement of retaining wall to the south. As a result the building tilted precariously at about 1 in 40. A typical surface expression of ground cracking is shown in Figure 13(a). When the underside of footings were excavated, the PC piles were found to have inclined by a large angle as shown in Figure 13(b) as a typical example.

(a) Crack ripping through the concrete

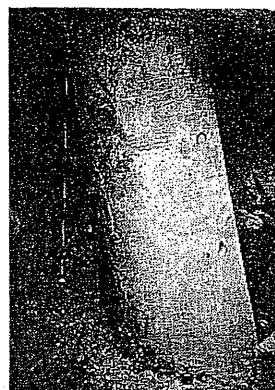
(b) Conspicuously inclination of PC pile

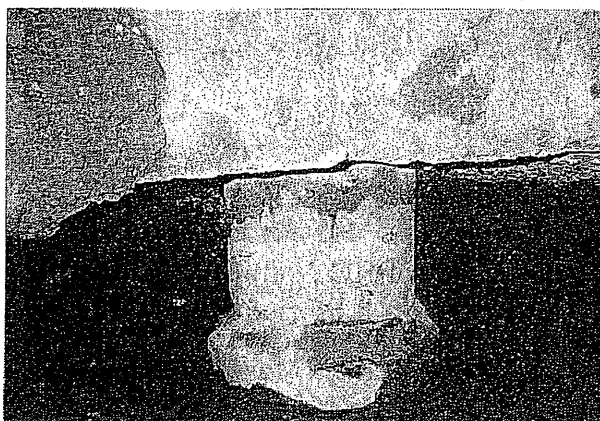
(a) Location where the ground moved laterally by about 150mm

Figure 14(a) shows the nodular pile supporting a factory building in a reclaimed site right next to the quay wall. The factory building was found to have moved seaward by

up to 400mm close to the quay wall due to lateral spreading probably resulting from soil liquefaction. The underside of the footing was excavated to directly inspect the top of piles for possible damage. There was reportedly no evidence of undue distress to the 11m PHC nodular piles supporting the the building.

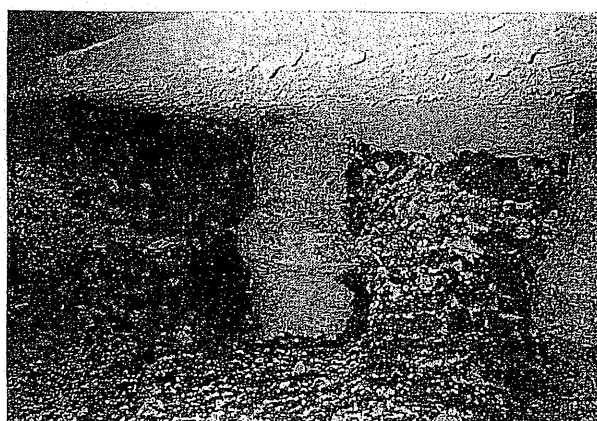
(b) Filled site with clear evidence of ground settlement

Figure 14(b) shows another example of excavation inspection of PHC nodular pile. In this case a 5 storied RC building was supported by 13m long nodular piles in a filled ground. Originally the site was a pond. The ground was found to settle by about 10cm relative to the building plinth. Although there was practically no damage to the superstructure, the foundation was excavated for direct inspection because of the relative settlement. As can be seen in Figure 14(b), there was no damage in the PHC nodular piles supporting the building.
