# A CASE STUDY ON THE PILE FOUNDATION DAMAGE DURING THE HYOGOKEN-NAMBU (KOBE) EARTHQUAKE

Madan B. Karkee\* and Hideaki Kishida\*\*

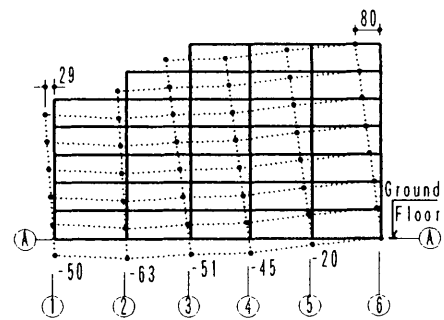
The building was located within the area of the highest JMA intensity of seven. Detailed measurement indicated that the building roof was out of plumb by 80mm as shown in Fig. 1, a tilt of about 1 in 250. The maximum differential settlement at the plinth level was more than 90mm. As also indicated by the damage statistics (Karkee et al, 1977), existence of such significant tilting constitutes strong possibility of foundation damage. Excavation was carried out to expose for direct inspection the prestressed high strength concrete (PHC) piles supporting the building. It was found that most of the piles had completely failed. A typical damage to a PHC pile looking from four mutually perpendicular directions is shown in Fig. 2.

Fig. 1 : Extent of Tilting in the Building

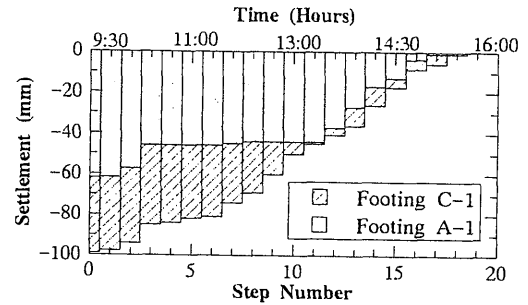
Fig.3 : Recovery of Differential Settlement

Steel pipe piles (SPP) were installed under the footings by jacking against the building weight for temporary support of the building. Once the building load was transferred to SPP, and damaged portion of piles were cut-off from the footing, the jack-up operation was carried out. The jack-up process involved careful operation of selected jacks at a time with constant monitoring of the extent of settlement recovery. The result of monitoring at two of the footings is shown in Fig.3, where recovery of settlement at different loading step can be seen including the time taken for the operation. The building was jacked-up practically to its original plumb and level, and then finally repaired and strengthened.

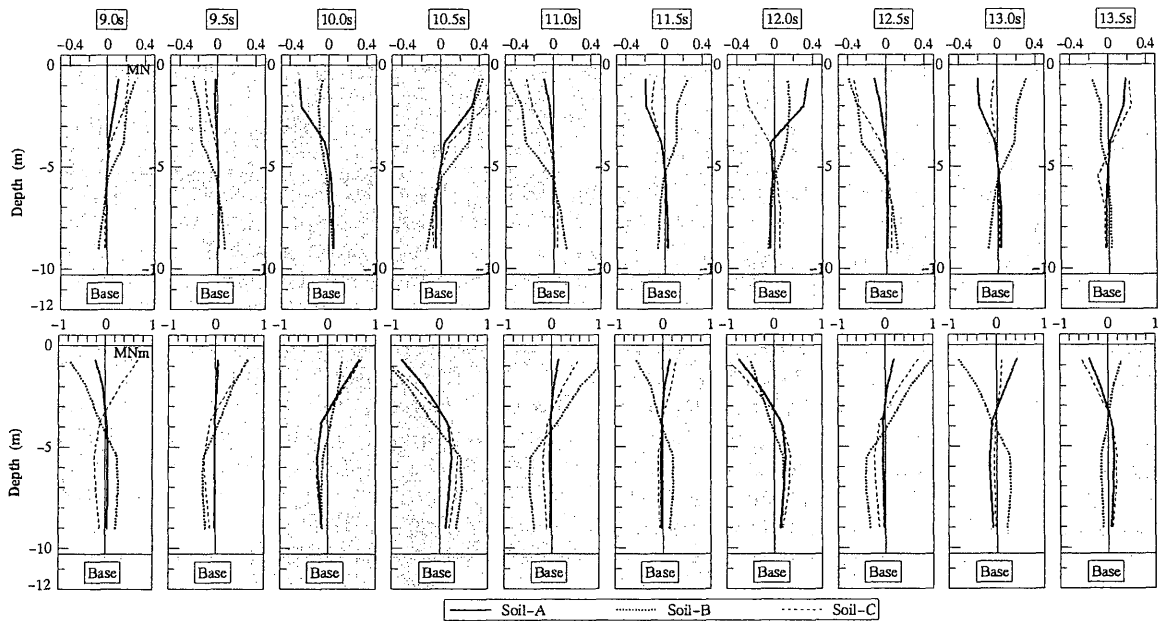
Fig.4 : Shear Force and Bending Moment Distribution in Piles from 1-D Seismic Response Analysis

Fig.4 shows that the shear force as well as the bending moment is largest at around 11s in case of B-soil, which corresponds to the side of the building that underwent largest differential settlement. Such combination of seismic actions may have resulted in the failure of pile shown in Fig.2. It is noted that simple 1-D free field and soil-pile-building interaction analysis can explain the essential behavior of piles during earthquake shaking.
