BEHAVIOR OF FRICTION PILES DURING THE HYOGOKEN-NAMBU EARTHQUAKE AND ITS IMPLICATIONS TO THE DESIGN PRACTICE

Abstract

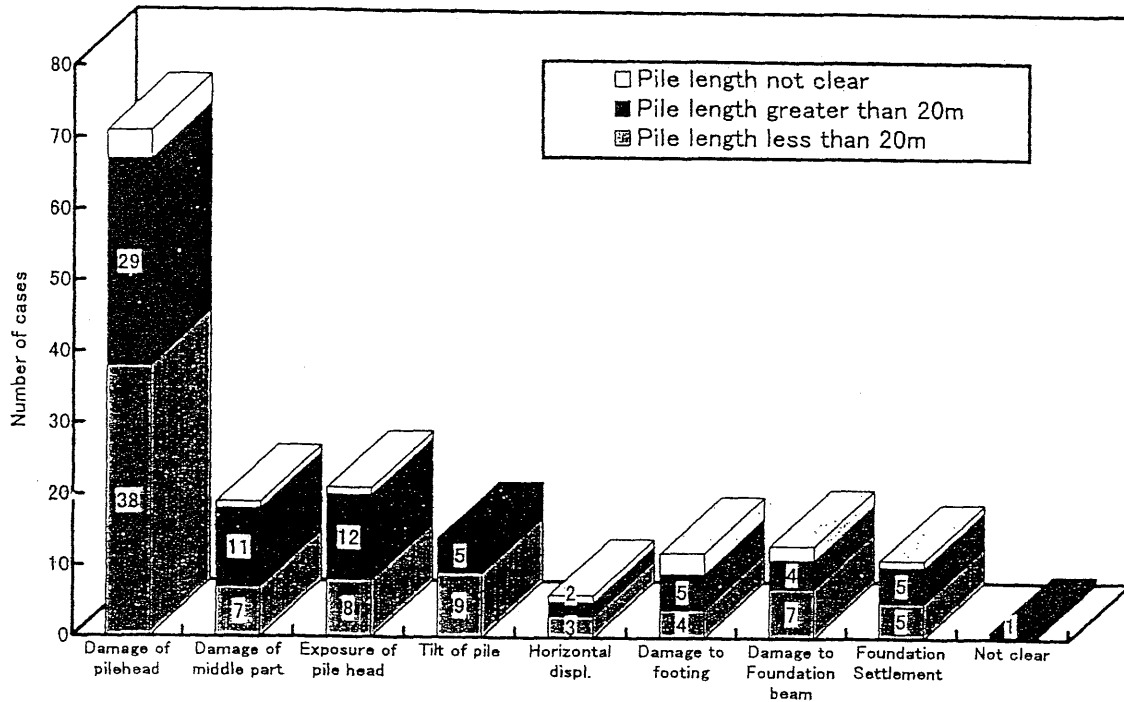
Figure 5 The nature of Pile Foundation Damage and the Pile length

Figure 5 shows the relationship of the pile length with the type of pile foundation damage. Damage near the pile head, including cracking and other modes of failure, is seen to be clearly dominant. Other types of damage are more or less evenly distributed. It is not clearly evident what portion of the damage near the pile head can be attributed to the inertial forces of the superstructure under the earthquake excitation, but it may be quite significant particularly in

case of relatively shorter piles. The ductility of pile material is important in seismic design. But the high instances of the damage at or near the pile head clearly indicates particularly predominant importance of the ductility demand near the top of piles. Damage at middle part of the piles, which is indicated by Figure 5 to be more frequent in case of longer piles, could be due either to the ground response effects emanating from uneven ground profile (e.g. Sugimura et al, 1997) or to the ground failure effects noted above.

The pile foundation damage statistics clearly show that the cracking other mode of failure at or near the pile head was the dominant form of damage, while other types of damage was more or less evenly distributed. This is a clear indication of the need for provision of the ductility, particularly at the top portion of the pile.

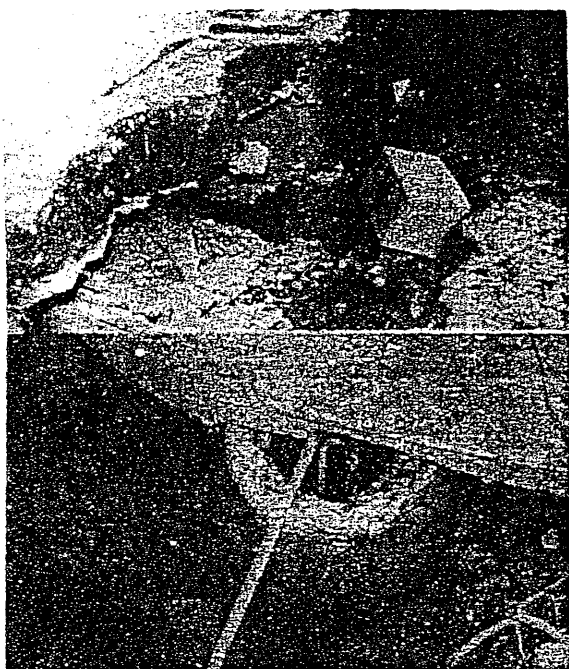
Figure 6 shows the effect of significant lateral ground movement on the piles. Figure 6(a) shows the case of a 14m long RC (reinforced concrete) pile supporting a 2 storied steel structure in a reclaimed site about 20m from the quay wall. There

was extensive settlement and lateral spreading due to liquefaction. Ground settlement of the order of 60~100cm was observed. The RC pile was completely broken off due to the lateral ground movement. Similarly, Figure 6(b) shows the failure of a PC (prestressed concrete) pile of unknown length supporting a 1 storied concrete building in ordinary ground. The building was located about 10m from the quay wall. The ground settlement was of the order of about 200cm primarily caused by the seaward movement of ground. As can be very severe indeed.

(a) ϕ 350 RC Pile at a Reclaimed Site with Liquefaction and lateral Spreading
