EFFECTS OF REMEDIAL MEASURES AGAINST LIQUEFACTION  
AT 1993 KUSHIRO-OKI EARTHQUAKE

S. Iai<sup>1)</sup>, Y. Matsunaga<sup>1)</sup>, T. Morita<sup>1)</sup>, M. Miyata<sup>1)</sup>, H. Sakurai<sup>1)</sup>,  
H. Oishi<sup>2)</sup>, H. Ogura<sup>3)</sup>, Y. Ando<sup>4)</sup>, Y. Tanaka<sup>5)</sup> and M. Kato<sup>5)</sup>

1) Port and Harbour Research Institute, Yokosuka, Japan

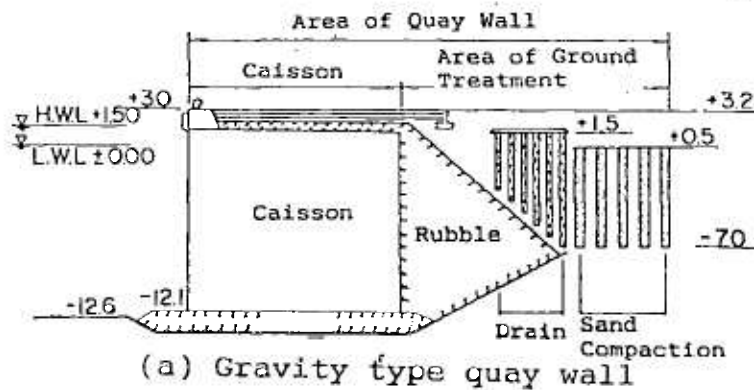
(a) Gravity type quay wall

From the point of view of measures against liquefaction, the backfilled part of ground consisting of rubble behind a wall shown in Fig. 14 might be regarded as treated area as measures against liquefaction. Though the area of this part is not wide enough to cover whole area of active earth failure zone, this
