LIQUEFACTION-INDUCED DAMAGE TO BUILDINGS IN 1990 LUZON EARTHQUAKE

By Kohji Tokimatsu,¹ Associate Member, ASCE, Hisaya Kojima,²
Shinichi Kuwayama,³ Akio Abe,⁴ and Saburoh Midorikawa⁵

ABSTRACT: The Luzon Earthquake of 1990 ($M_s = 7.8$) caused soil liquefaction in a widespread area that in turn caused crucial damage to various structures. After presenting an overview of the geotechnical aspects of the earthquake, this paper describes damage patterns of buildings in Dagupan City where fine to silty sands liquefied extensively. Also presented are geomorphological conditions, Standard Penetration Test (SPT) results, and shear wave velocity (V_s) profiles determined by a Rayleigh wave method; and their relations to the building damage of the city. The buildings that suffered large settlement and tilting are found to be concentrated in the banks of active rivers and in the fills built on recently abandoned river channels. It is found that the currently available empirical correlations using SPT N -value can well estimate the extent of liquefaction-induced damage to buildings. The Rayleigh wave method used shows capability in determining cross sections of V_s structure in the near surfac

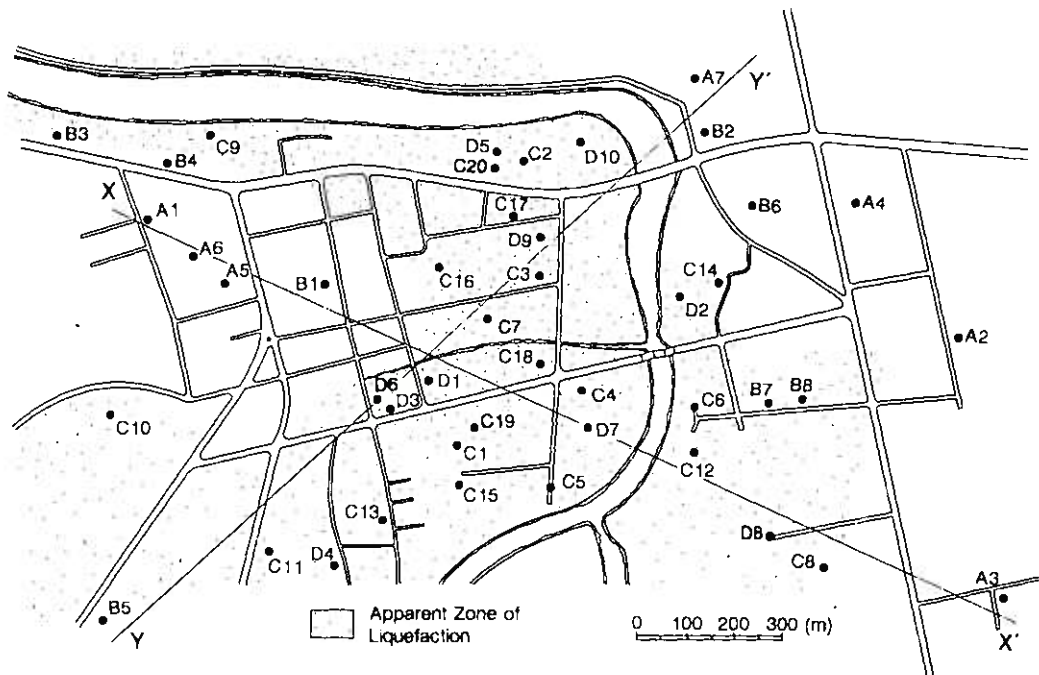
FIG. 13. Locations of Sites for Rayleigh Wave Investigation

Dagupan mainly observes Rayleigh waves in short-period microtremors. The test procedure and test equipment used are the same as those reported by Tokimatsu et al. (1992). The test equipment is portable as it consists only of sensors, amplifiers, and a laptop computer. Besides, the test can readily be run on the ground surface by measuring microtremors with a small array of sensors. This enables one to conduct a large number of tests within a short period. The tests were conducted at 45 sites that are distributed over liquefied and nonliquefied zones as shown in Fig. 13. The extent of

damage to structures at each site is classified into four categories from A to D cited previously, and the site is labeled accordingly. Figs. 14 and 15 show cross sections of V_s structure along $X-X'$ and $Y-Y'$ lines shown in Fig. 13. The V_s profiles in the affected area contrast well with those in the unaffected area in the following manners. The shear wave velocity of the top layer is less than 85 m/s in the severely affected area, and more than 85 m/s in the other area. Comparison of Figs. 13 and 14 with Fig. 7 further reveals that the soft surface layer with V_s less than 85 m/s occurs only near the active river and on recently abandoned river channels. In much of the affected area, the layer with V_s less than 130 m/s exists to a depth more than 5 m. In the unaffected area, in contrast, such a layer with V_s less than 130 m/s exists generally at depths smaller than about 5 m. In the affected area, a stiff layer with V_s greater than 165 m/s occurs generally at depths greater than 12 m but in the unaffected area at depths less than 8 m. A similar tendency can be seen at all test sites as summarized in Fig. 16, in which both the depths to layers with $V_s \geq 130$ and ≥ 165 m/s tend to increase as the extent of damage to buildings increases.

From Figs. 13–16, representative values of shear wave velocities at a critical depth of 5 m are 140, 130, 120, and 110 m/s for categories A to D sites, respectively. Based on these values, the relation between the normalized shear wave velocity and the stress ratio corresponding to $M = 7.5$ conditions at the critical depth of four category sites were estimated, and are plotted in Fig. 17. Also shown in the figure are the data from the 1979 Imperial Valley ($M_s = 6.5$) and 1981 Westmorland ($M_s = 5.6$) earthquakes (Stokoe et al. 1988) for which correction has been also made to the stress ratio to allow for the difference in earthquake magnitude. The proposed chart is consistent with the field observation, indicating its potential usefulness, though further field verification is evidently needed.
