A NEW BUILDING INFLICTED BY THE KOBE EARTHQUAKE OF JANUARY 17, 1995 AND THE MEASURES TAKEN TO RESTORE AND STRENGTHEN THE FOUNDATION-BUILDING SYSTEM

Kenya Harasawa,¹⁾ Madan B. Karkee²⁾ and Hideaki Kishida³⁾

A new building in the city of Nishinomiya, near Kobe, was just ready for hand over when the January 17, 1995 earthquake occurred. The building looked structurally intact, but the piles supporting it were found to have been completely damaged. A comprehensive plan involving a tricky simultaneous operation of 61 hydraulic jacks was developed and successfully implemented to jack-up and restore the foundation-building system. Luckily, there were no aftershocks closer in size to the main event during the implementation phase. The differential settlement and tilting were practically nil when the restoration was complete. The experience gained from the project is vital in future restoration and reconstruction of pile foundations damaged by extreme earthquake events.

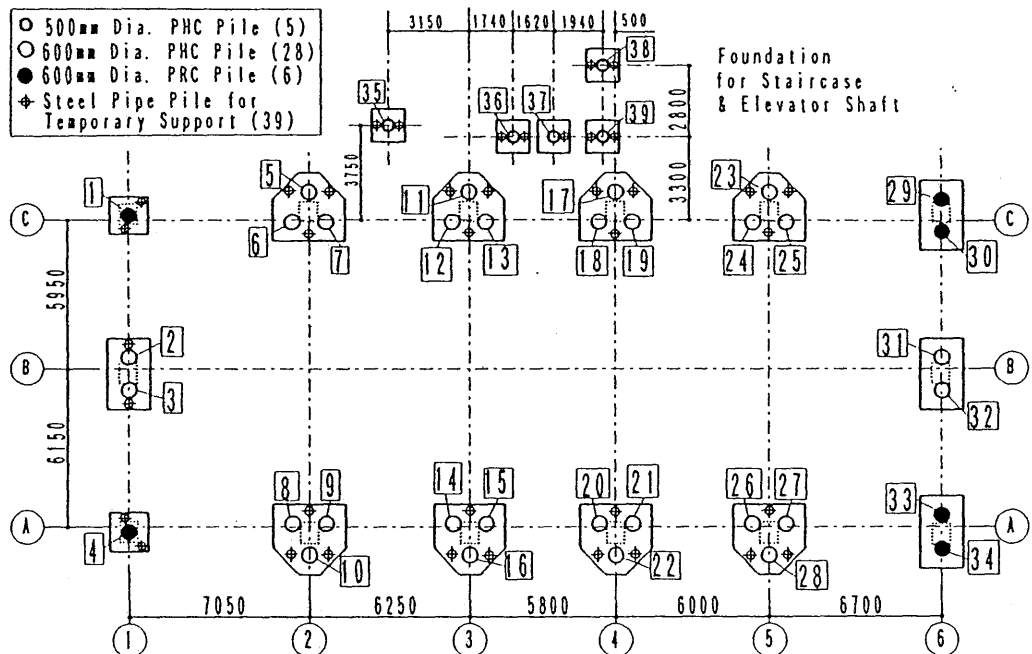
Figure 3: Building Foundation Plan Showing the Location of PHC and PRC Piles and Footings. The Crossed Circles Show Location of Steel Pipe Piles for underpinning.

The integers 1 to 39 inclosed by rectangles in the foundation layout of Figure 3 are the sequential pile numbers. All the piles supporting the building are of 600mm external diameter,

except for the six supporting the staircases and the elevator shaft (numbered 35 to 39), which are of 500mm. The respective locations of PRC and PHC piles are also indicated in Figure 3. The Cross-sections of the $\phi 600$ mm PHC and PRC piles, together with that of $\phi 500$ mm PHC pile are shown in Figure 4. The prestressing strands, helical shear reinforcement and longitudinal rebars where applicable, are also given. All the piles were 9.0m long, except for the four numbered 36 to 39 in Figure 3, which were 8.0m long.

Installation was carried out at all the footings up to step 7, so that the simultaneous jacking-up operation described below could be undertaken. It was found that all the piles supporting the building had failed except for the six numbered 29 to 34 in Figure 3, where the steel pipe piles can be noted to be absent in footings 6A, 6B and 6C. Once the building structure was jacked up (step 8 in Figure 10) against the reaction blocks to correct for differential settlement and tilting, further reinforcements were placed on top of the reaction block (step 9) and concrete was poured (step 10) to confine the top of piles. The jacking operation is discussed in more detail below. Finally, non-compressible mortar was injected below the footing (step 11) so as to transfer the footing load to the confining concrete block below, and the excavation was filled back (step 12).

footing to expose top of piles to a depth of about 3.5m below the existing ground level. Then the steel pipe piles were installed statically by jacking against the underside of footing. Altogether 39 steel pipe piles (26 $\phi 355.6 \times 9.5$ mm thick and 13 $\phi 318.5 \times 7.9$ mm thick) were installed. The bearing capacity was directly measured as the piles were being installed. The maximum load for installation was considered to be 2.0MN. for larger diameter steel piles and 1.0MN for smaller ones. The layout of the steel pipe piles is shown in Figure 3 above.

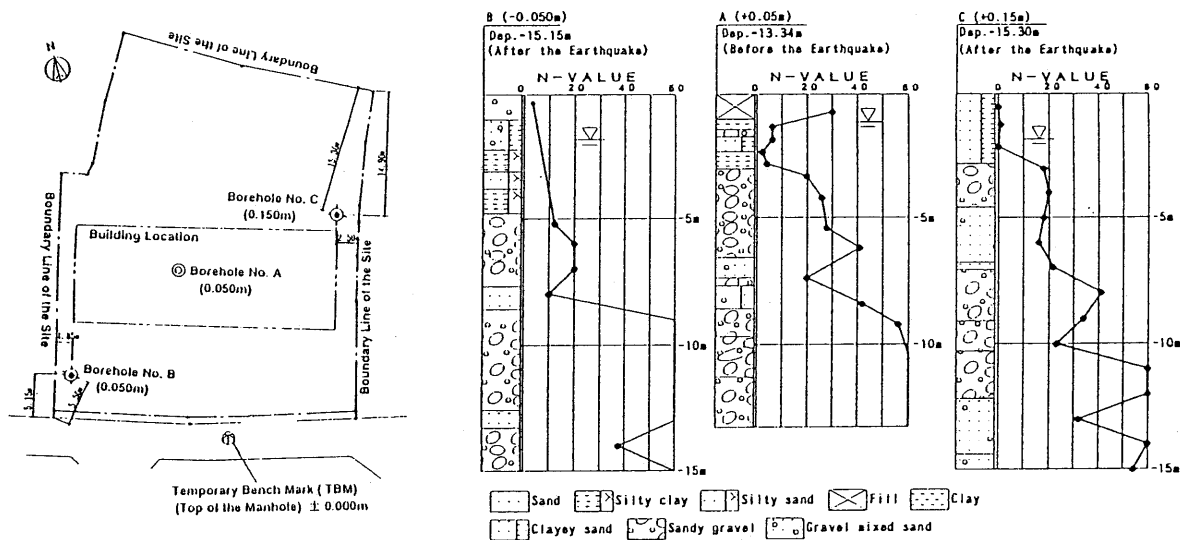
Figure 8: Location of Boreholes and Soil Profiles. (Borehole A is from before the building was constructed, and boreholes B & C were drilled after the earthquake).

Detailed measurements were made subsequently. The location map of boreholes in Figure 8 shows the temporary bench mark (TBM), relative to which settlements were measured. It was revealed that there was a differential settlement of about 90mm between eastern and western ends of the building, as seen in Figure 7. Note that the grid-line numbers given in Figure 7 correspond to those shown in the foundation plan in Figure 3. It was found that the south-east corner (A-6 in Figure 3) of the roof was out of the plumb-line by about 80mm as seen in Figure 7. It was inferred that such significant differential settlement and tilting of the building meant that the pile foundation supporting the structure must have incurred substantial damage. Skeletal frame analysis was carried out to evaluate the forces and moments exerted in different members due to the measured settlement and tilting of the building superstructure. This provided with a grasp of the existing state of stresses in the

The boring for soil exploration carried out for the purpose of the pile foundation design was located close to the center of the site as shown by borehole A in Figure 8. The site condition is fairly stiff as can be noted from the standard penetration test N-value profiles. The depth to underground water was about 1.0m from the ground level. Additional exploration borings were carried out after the event to see if there were any significant changes in the ground conditions because of the earthquake. The additional borings are indicated by B and C in Figure 8. It can be noted that the three borings together form a section through the site, and the soil profile broadly consists of alternate layers of sandy soil and sandy gravel of varying thickness. Overall, the soil profile can be considered to consist of 3 layers. There is surface

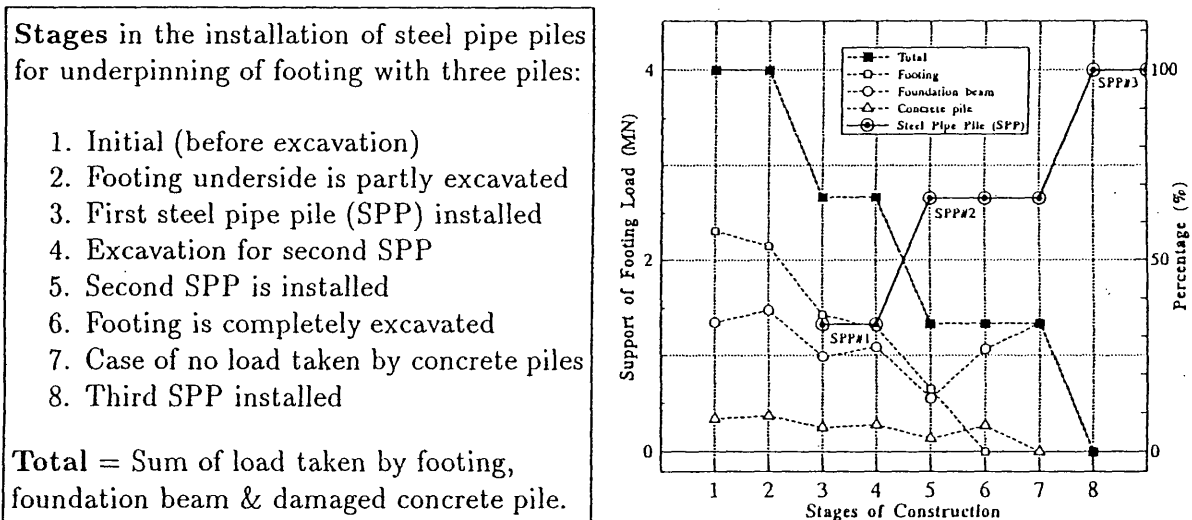
Figure 9: Load Sharing Pattern During the Installation of Steel Pipe Piles

A comprehensive restoration plan was developed based on the use of steel pipe piles for temporary support and the plan was successfully implemented. A typical scenario of changes in the share of a column load of about 4.0MN coming to a footing taken by different elements at different stages of construction is depicted in Figure 9. As can be noted, initially most of the footing load is taken by direct bearing of footing and foundation beams, and only a small part is borne by the damaged pile. There is a slight increase in the share of load taken by foundation beam and piles at stage 2 compared to that existing initially. However, this is of the order of only 10%, and was considered to be of not much concern.
